MEMO

To: Tom Ourada, City Administrator
Cc: Darcie Ross, Developer, Justin Crow, Engineer for Developer, Jesse Yager, Crete PW Dept.
From: Julie Ogden/Steve Parr
Date: September 25, 2025 *Updated October 14, 2025*
Subject: Burlington Estates, Updated Post Construction Document Review and Site Visit

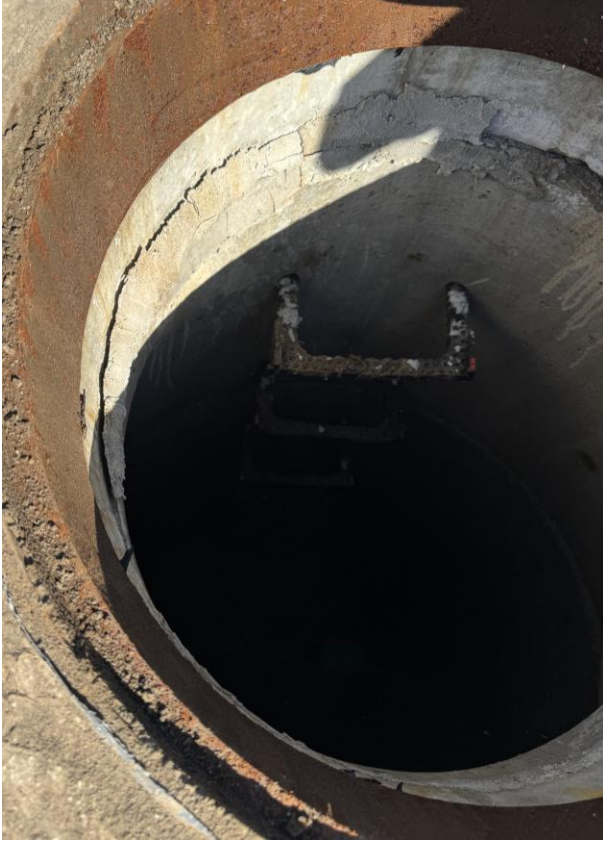
- ~~The adjustment rings had been grouted and in a few, the grout is already starting to peel off (see photo 1).~~
 - ~~Most of the manholes had debris in the bottom (concrete pieces/grout or soils) that needs to be cleaned out. (see photos 2 to 9)~~

Photo 1: grout in manhole

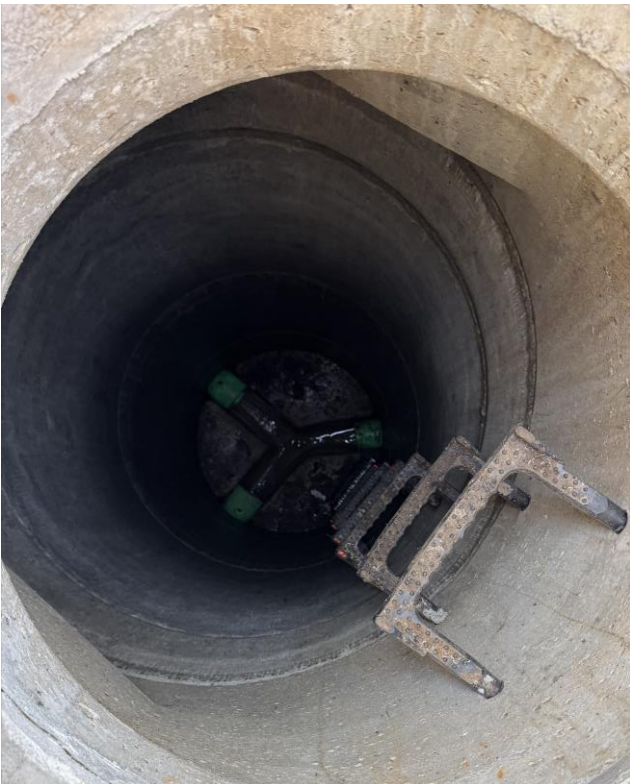
Photo 2: MH #3 debris in base

- ~~Cleaning and re-inspection with CCTV is required on the sanitary sewer lines due to the debris in the original video, the condition of the site (buried manholes, manhole rings off set from cones, etc) which could have allowed debris to enter the system.~~

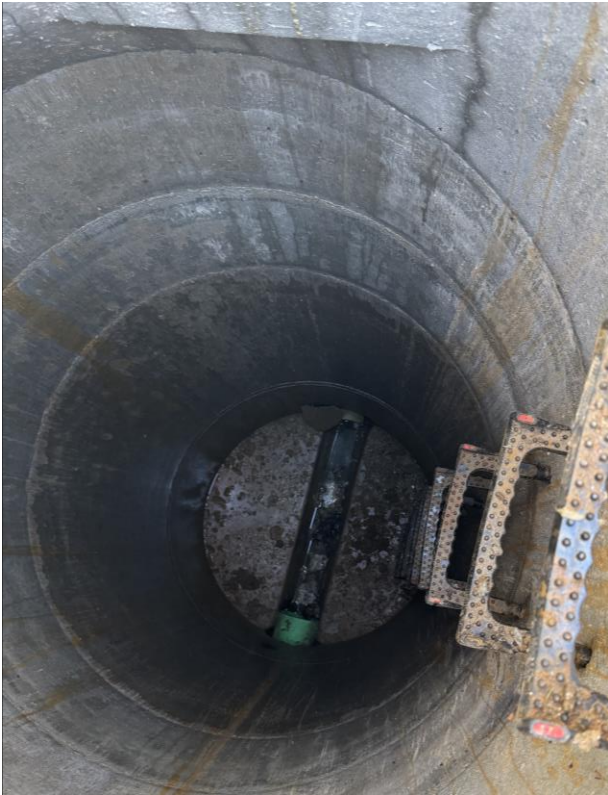
Photo 3: MH #4 debris in base

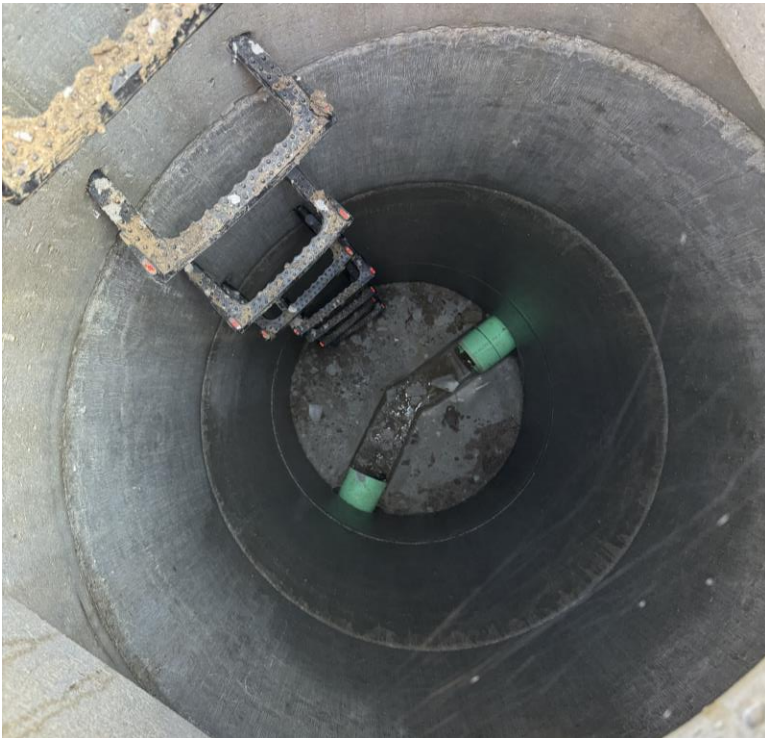
Photo 4: MH #7 debris in base

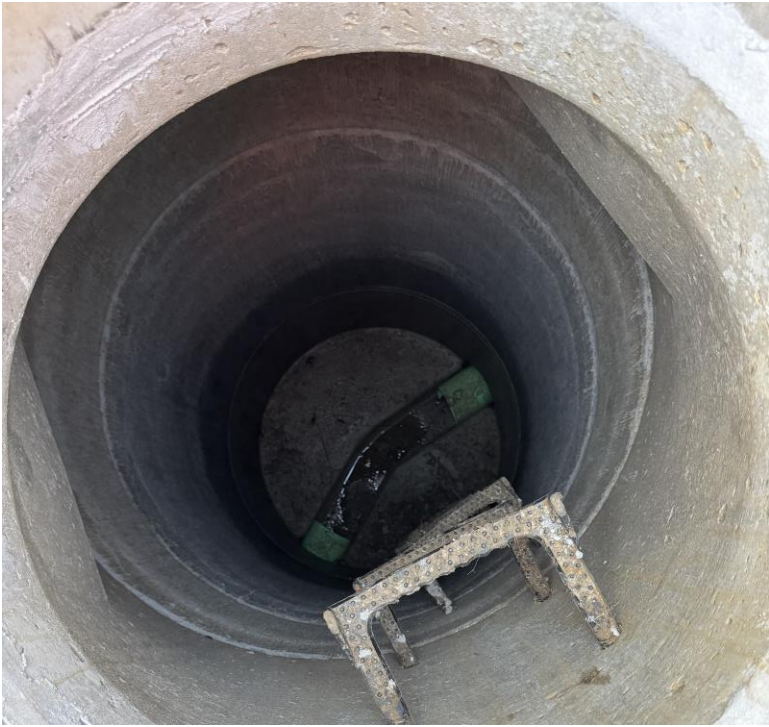
Photo 5: MH #8 debris in base

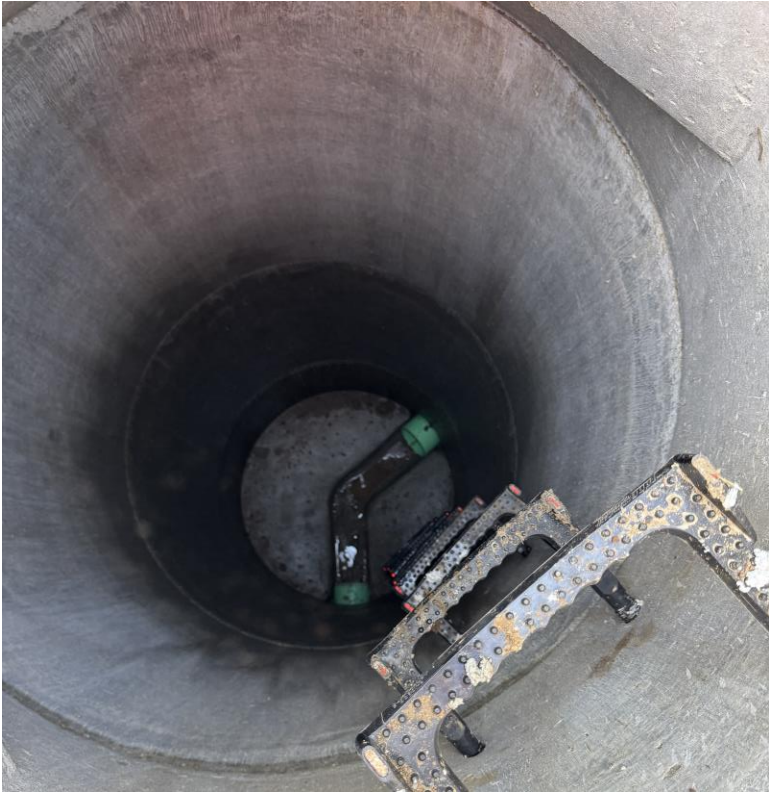
Photo 6: MH #9 debris in base

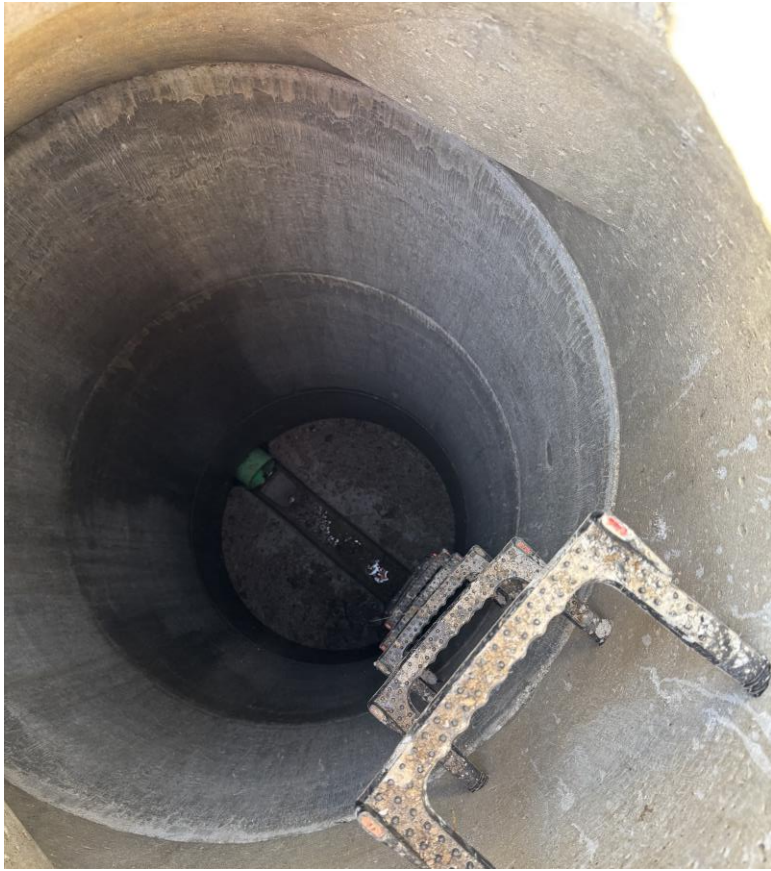
Photo 7: MH #10 debris in base

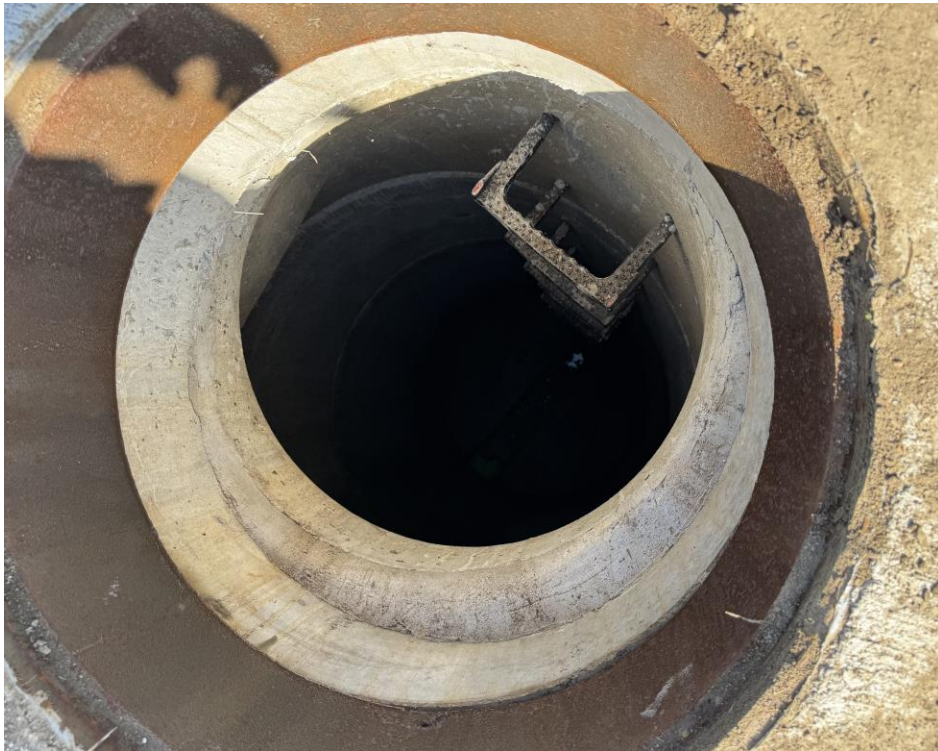
- ~~The adjustment rings at MH 10 were not set on top of the cone section. Appears to be grouted closed to prevent soil entering system but this should have been corrected prior to placing grout and concrete pad.~~

Photo 8: MH #10 adjustment rings not set on top of cone (about 2" off)

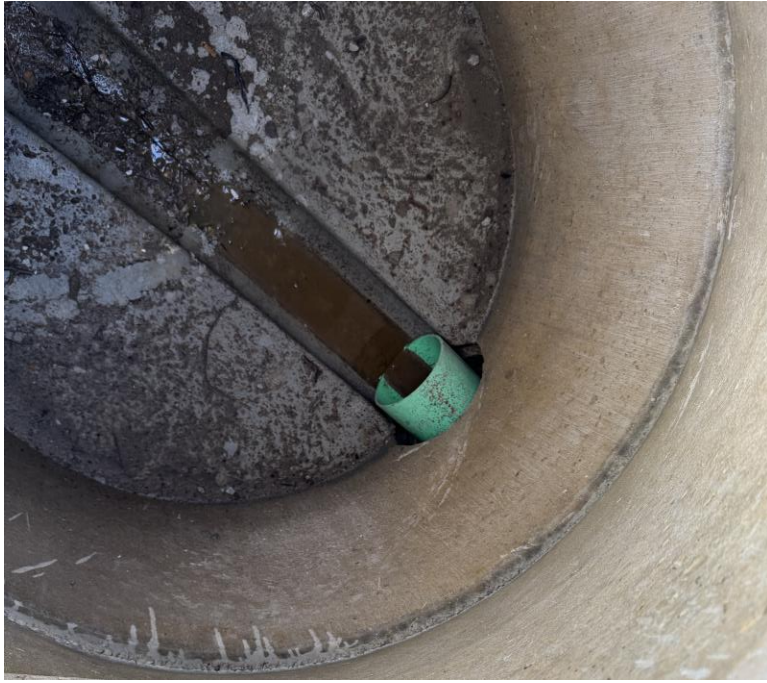
Photo 9: MH #13 debris in base & no grout inside MH around pipe

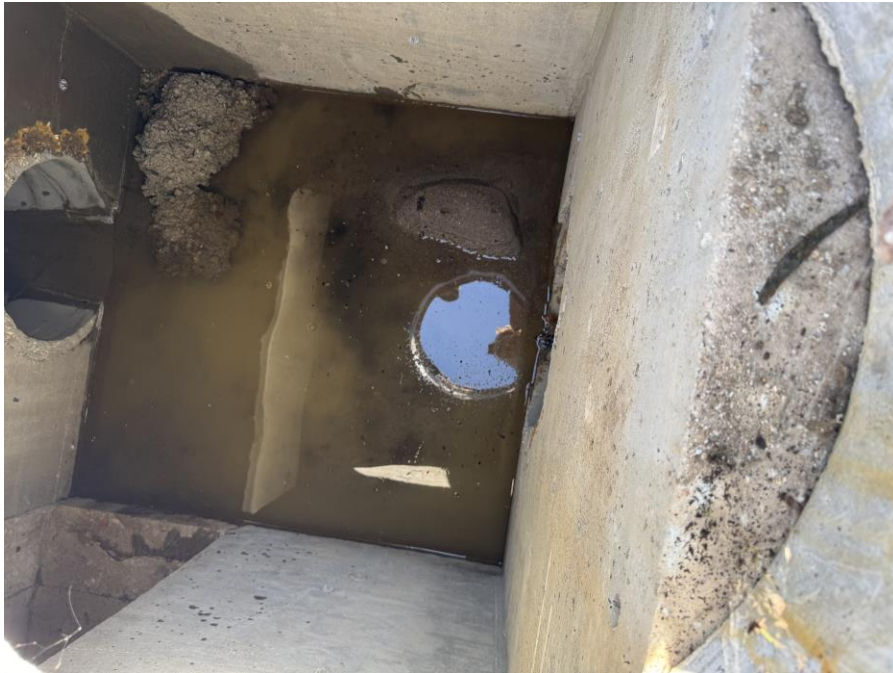
- ~~There is a lot of silt/debris within both storm inlets that needs to be cleaned out. Inlet protection should be provided (the type that fits inside the inlet throat is best for traffic use) to prevent future issues. (see photos 10 & 11) **Contractor provided to JEO that this has been done.**~~

Photo 10: debris and standing water inside storm inlet 4

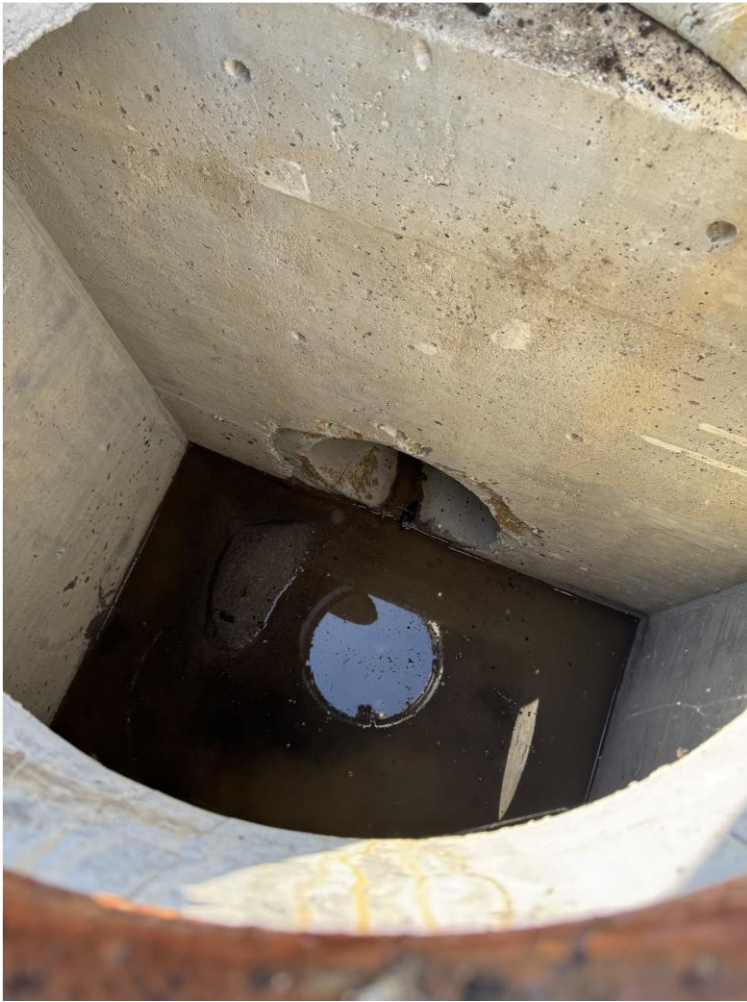
Photo 11: debris and standing water inside storm inlet 3 – floor of inlet is lower than pipe flowline creating standing water in inlet.

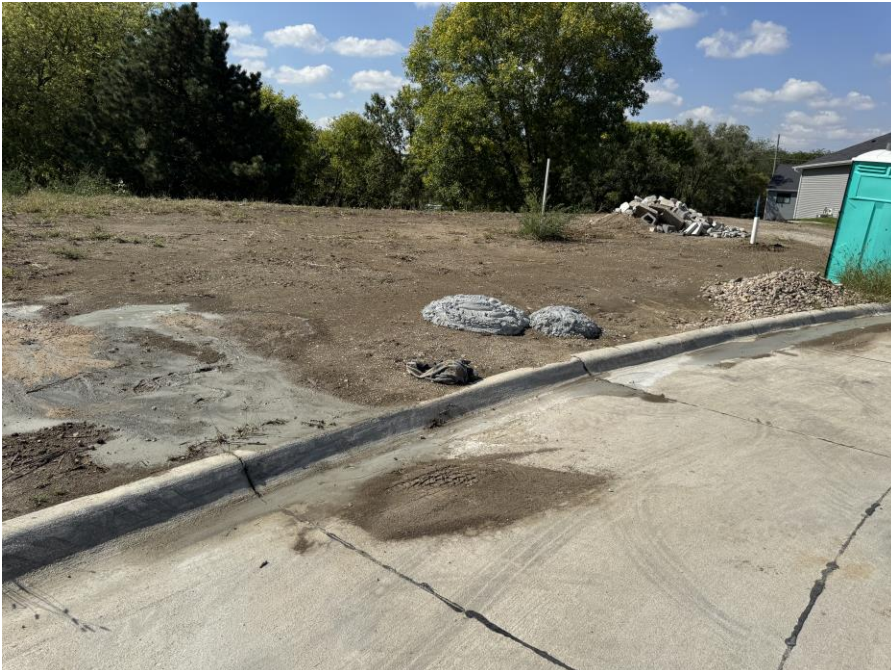
- Home builders are placing extra concrete or the truck washout right on bare subgrade which is not allowed and a concrete washout needs to be provided or required.
- It has been noted that the Notice of Termination was submitted to NDWEE on the existing permit but based on my review today, I have concerns about coverage and disturbances that are continuing and would recommend that the area continues to be monitored and cleaned up as needed.
- As houses are constructed, best management practices are still required including cleaning of the streets and protection of silt from entering the storm inlets.

Photo 12: concrete washout on ground
