Review of Building Conditions Assessment

# Board of Education Work Session

Dec 1, 2020

**November 2020**  
**BVH #19079**

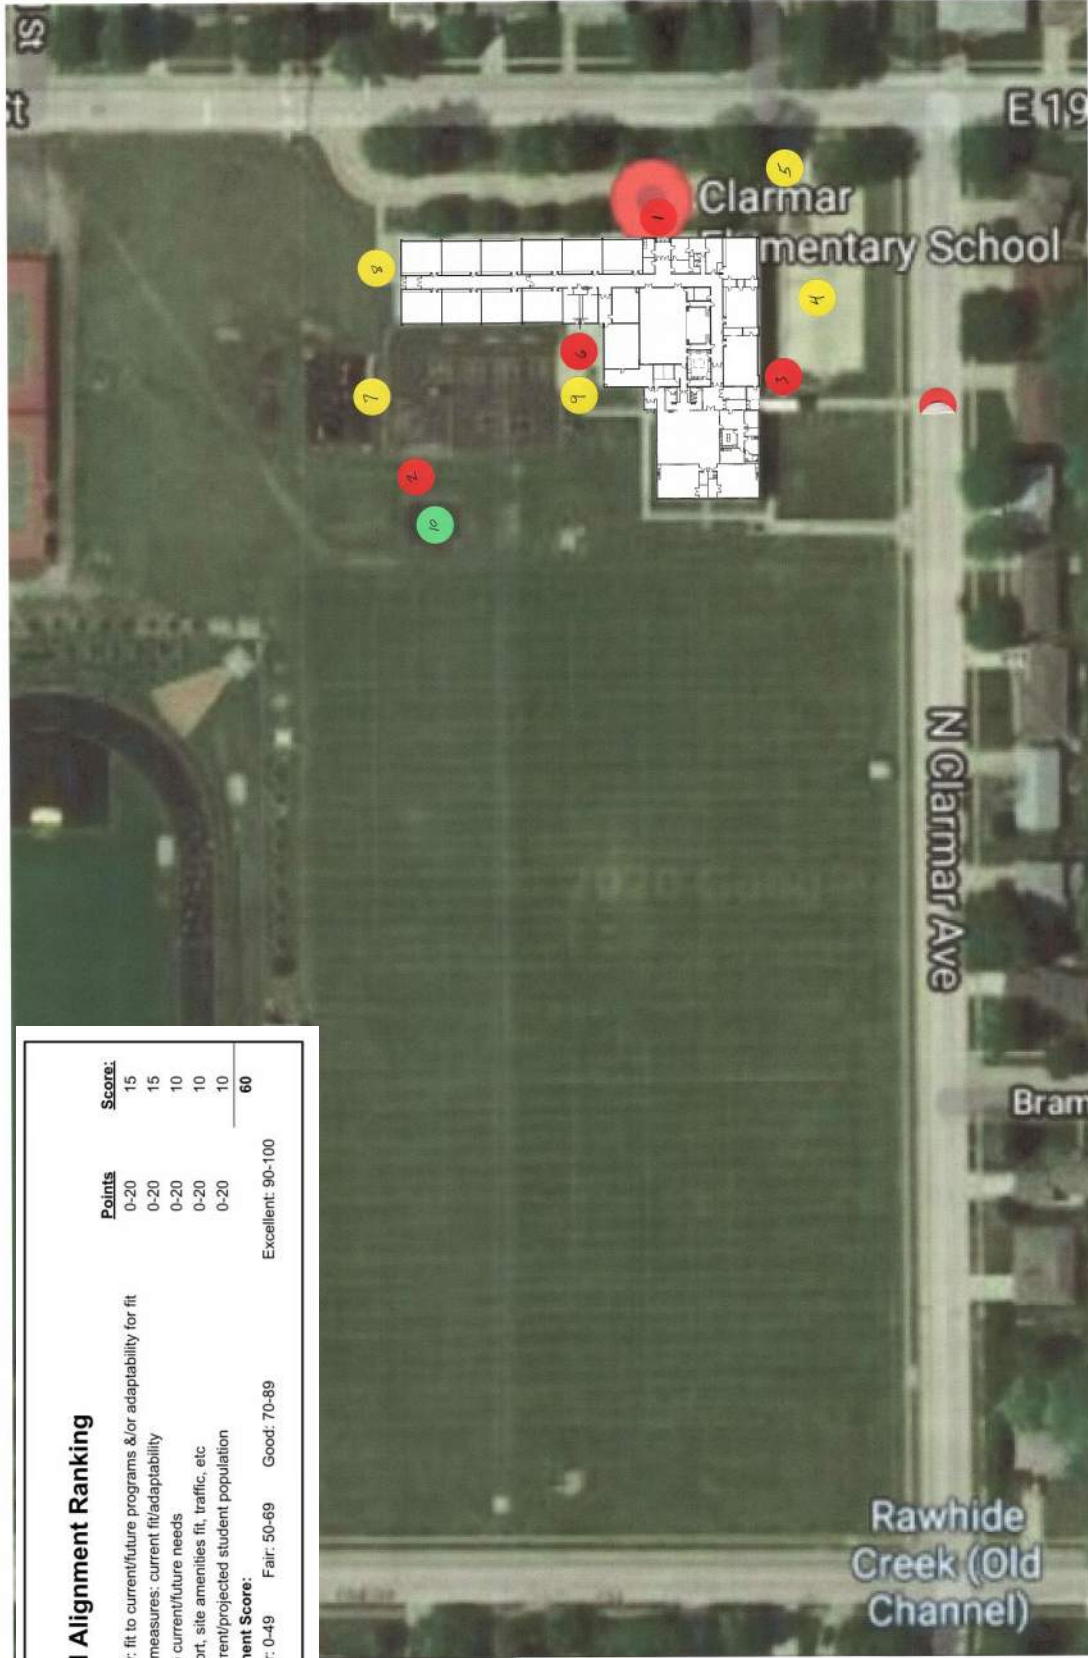
- L. All downspouts flow across sidewalks or onto playground leading to icy conditions
- M. Parking lot has tight turns and backs up traffic flow
- N. Additional cement space for recess when snowy/muddy/etc.

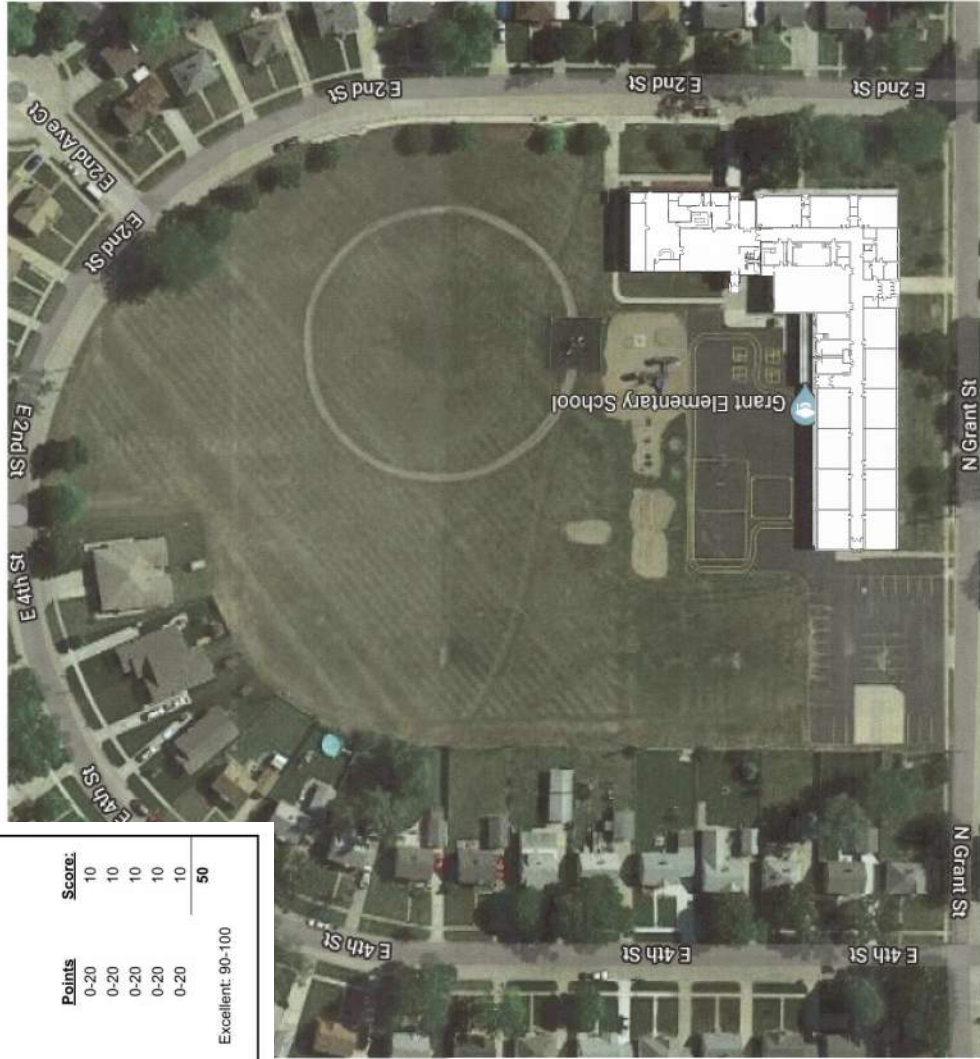
Carpet in every room needs replaced – hasn't been cleaned in forever.  
Restrooms need updated – can't clean well anymore.  
Parking lot – water collects and freezes, making falling hazard.  
Room 105 – too hot in summer months.  
Office 111/Office off stage – no ventilation.  
Sprinkler outside of Room 108 – broken.  
Storage rooms – floods.  
Corridor 115 – Outside doors do not close completely.  
Paint rooms in building.  
Speech 104 – carpet torn, tripping hazard.  
Boys restroom 101A – no ventilation, smells of urine.  
Copy room off Room 108 – smells musty due to leak.  
Improve handicapped parking and access to building.  
Good to be on one level.  
Kitchen – no freezer.  
Kitchen – needs updated to be functional.  
North end of Corridor 119 – unattached plate in floor (tripping hazard)  
Room 100 – no vent covers.  
Stage – temp fluctuations.  
Fuses blow when too many things plugged in on electrical strip below stage.

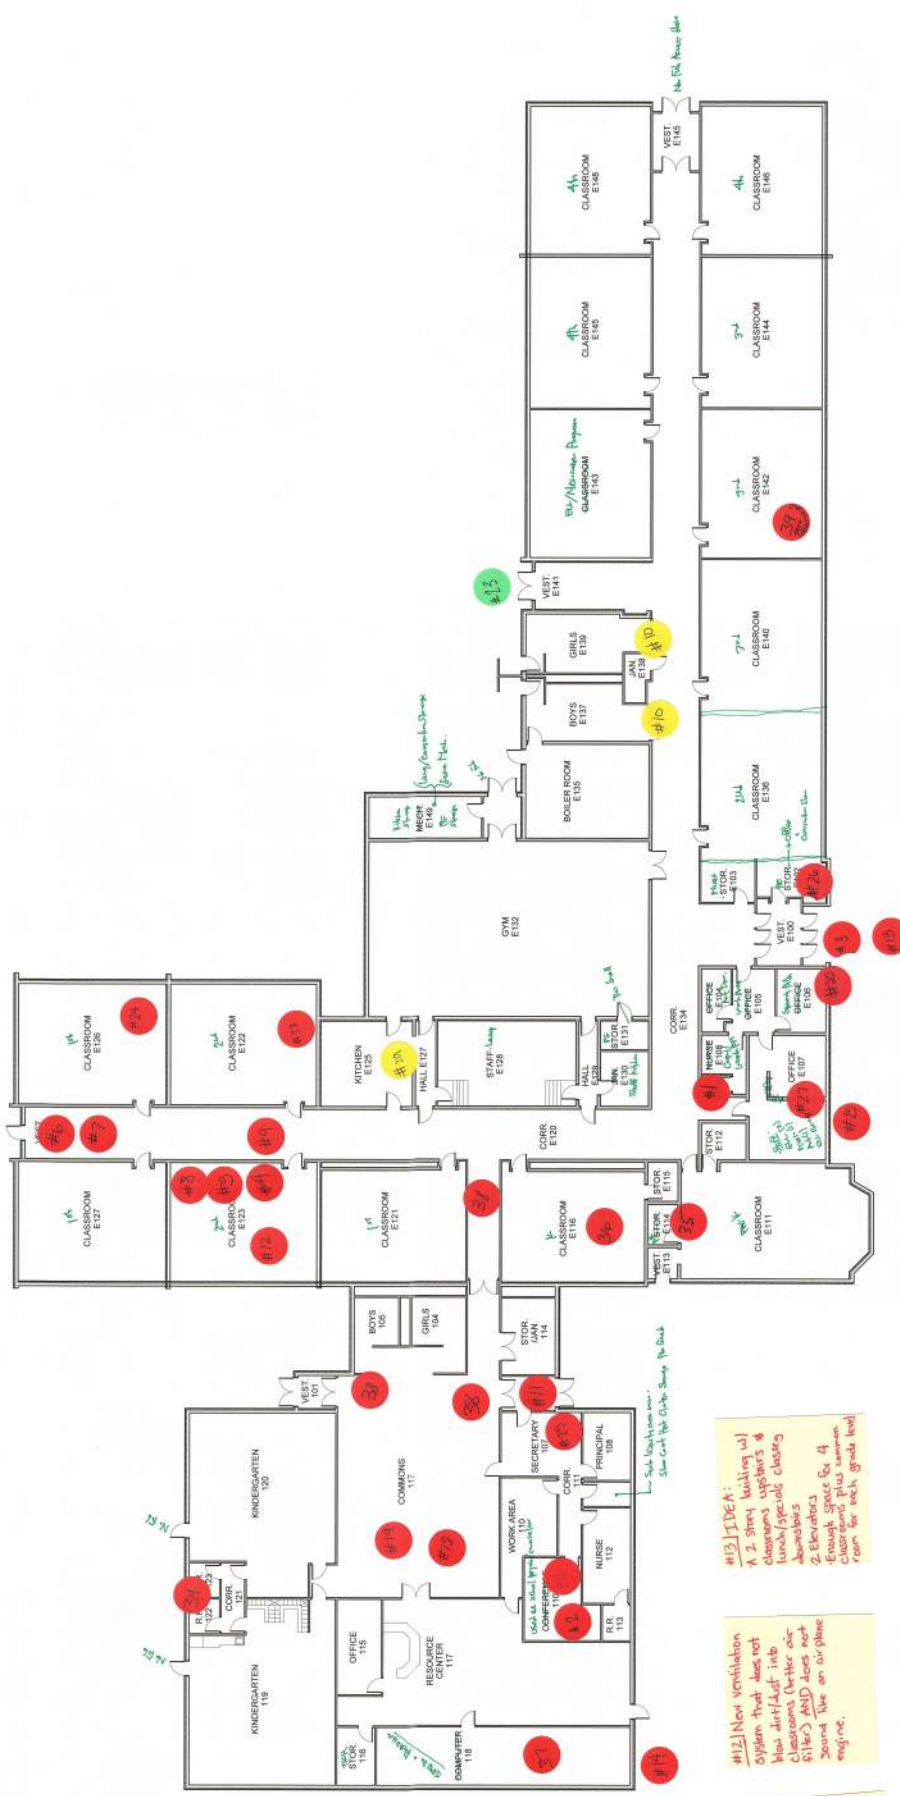
#14 Sidewalks &  
 railroad ties are  
 a trip hazard!

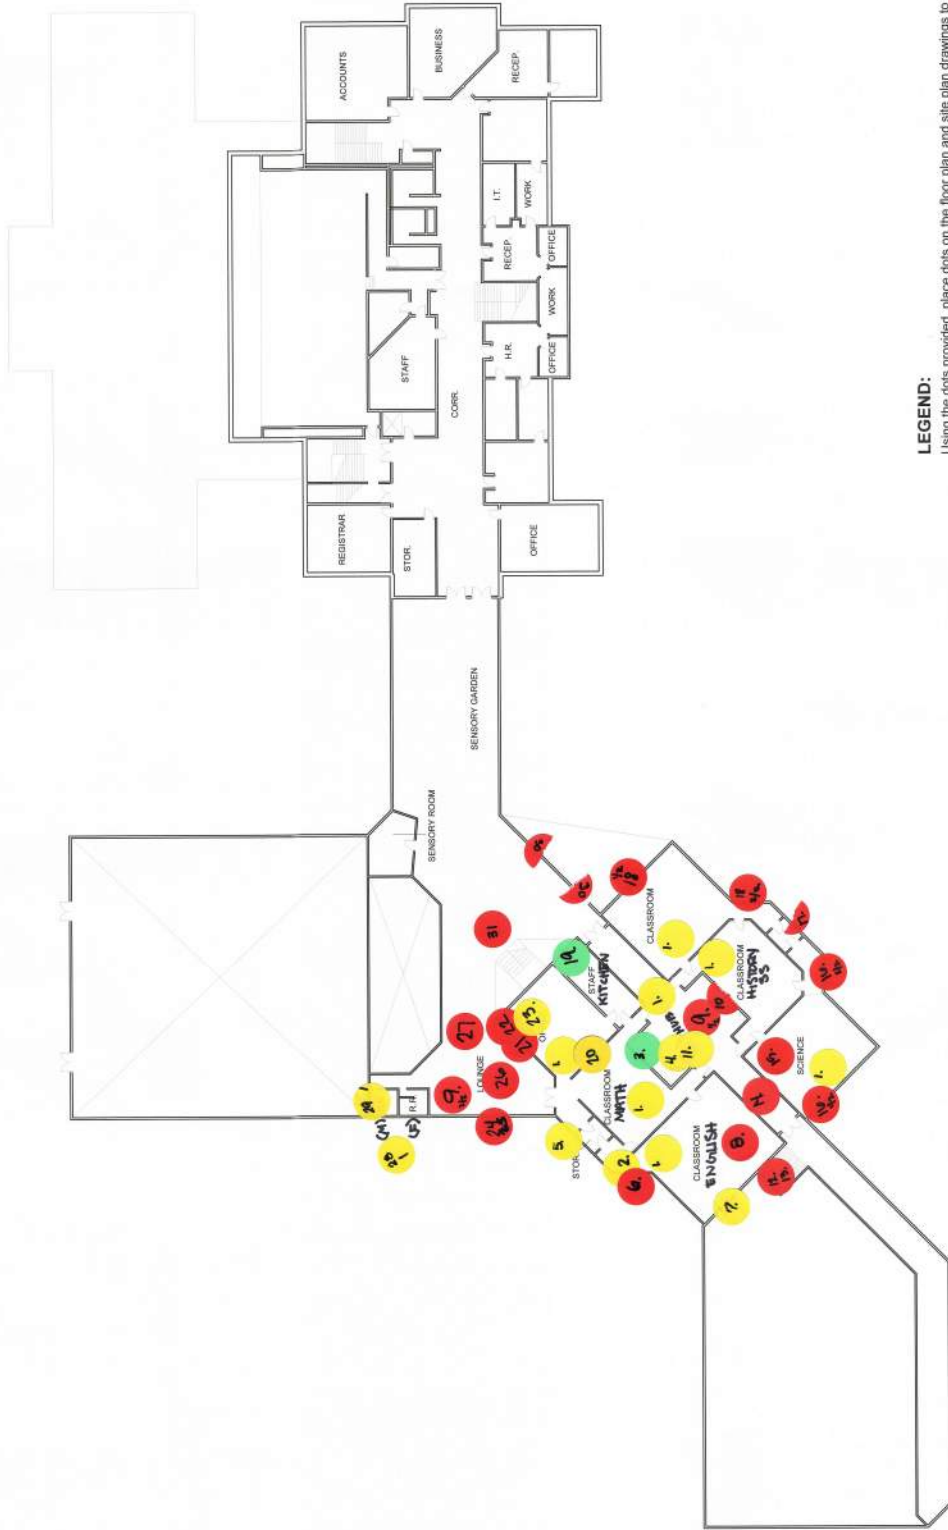
| 1-2-3 | Roof leaks in ceiling |

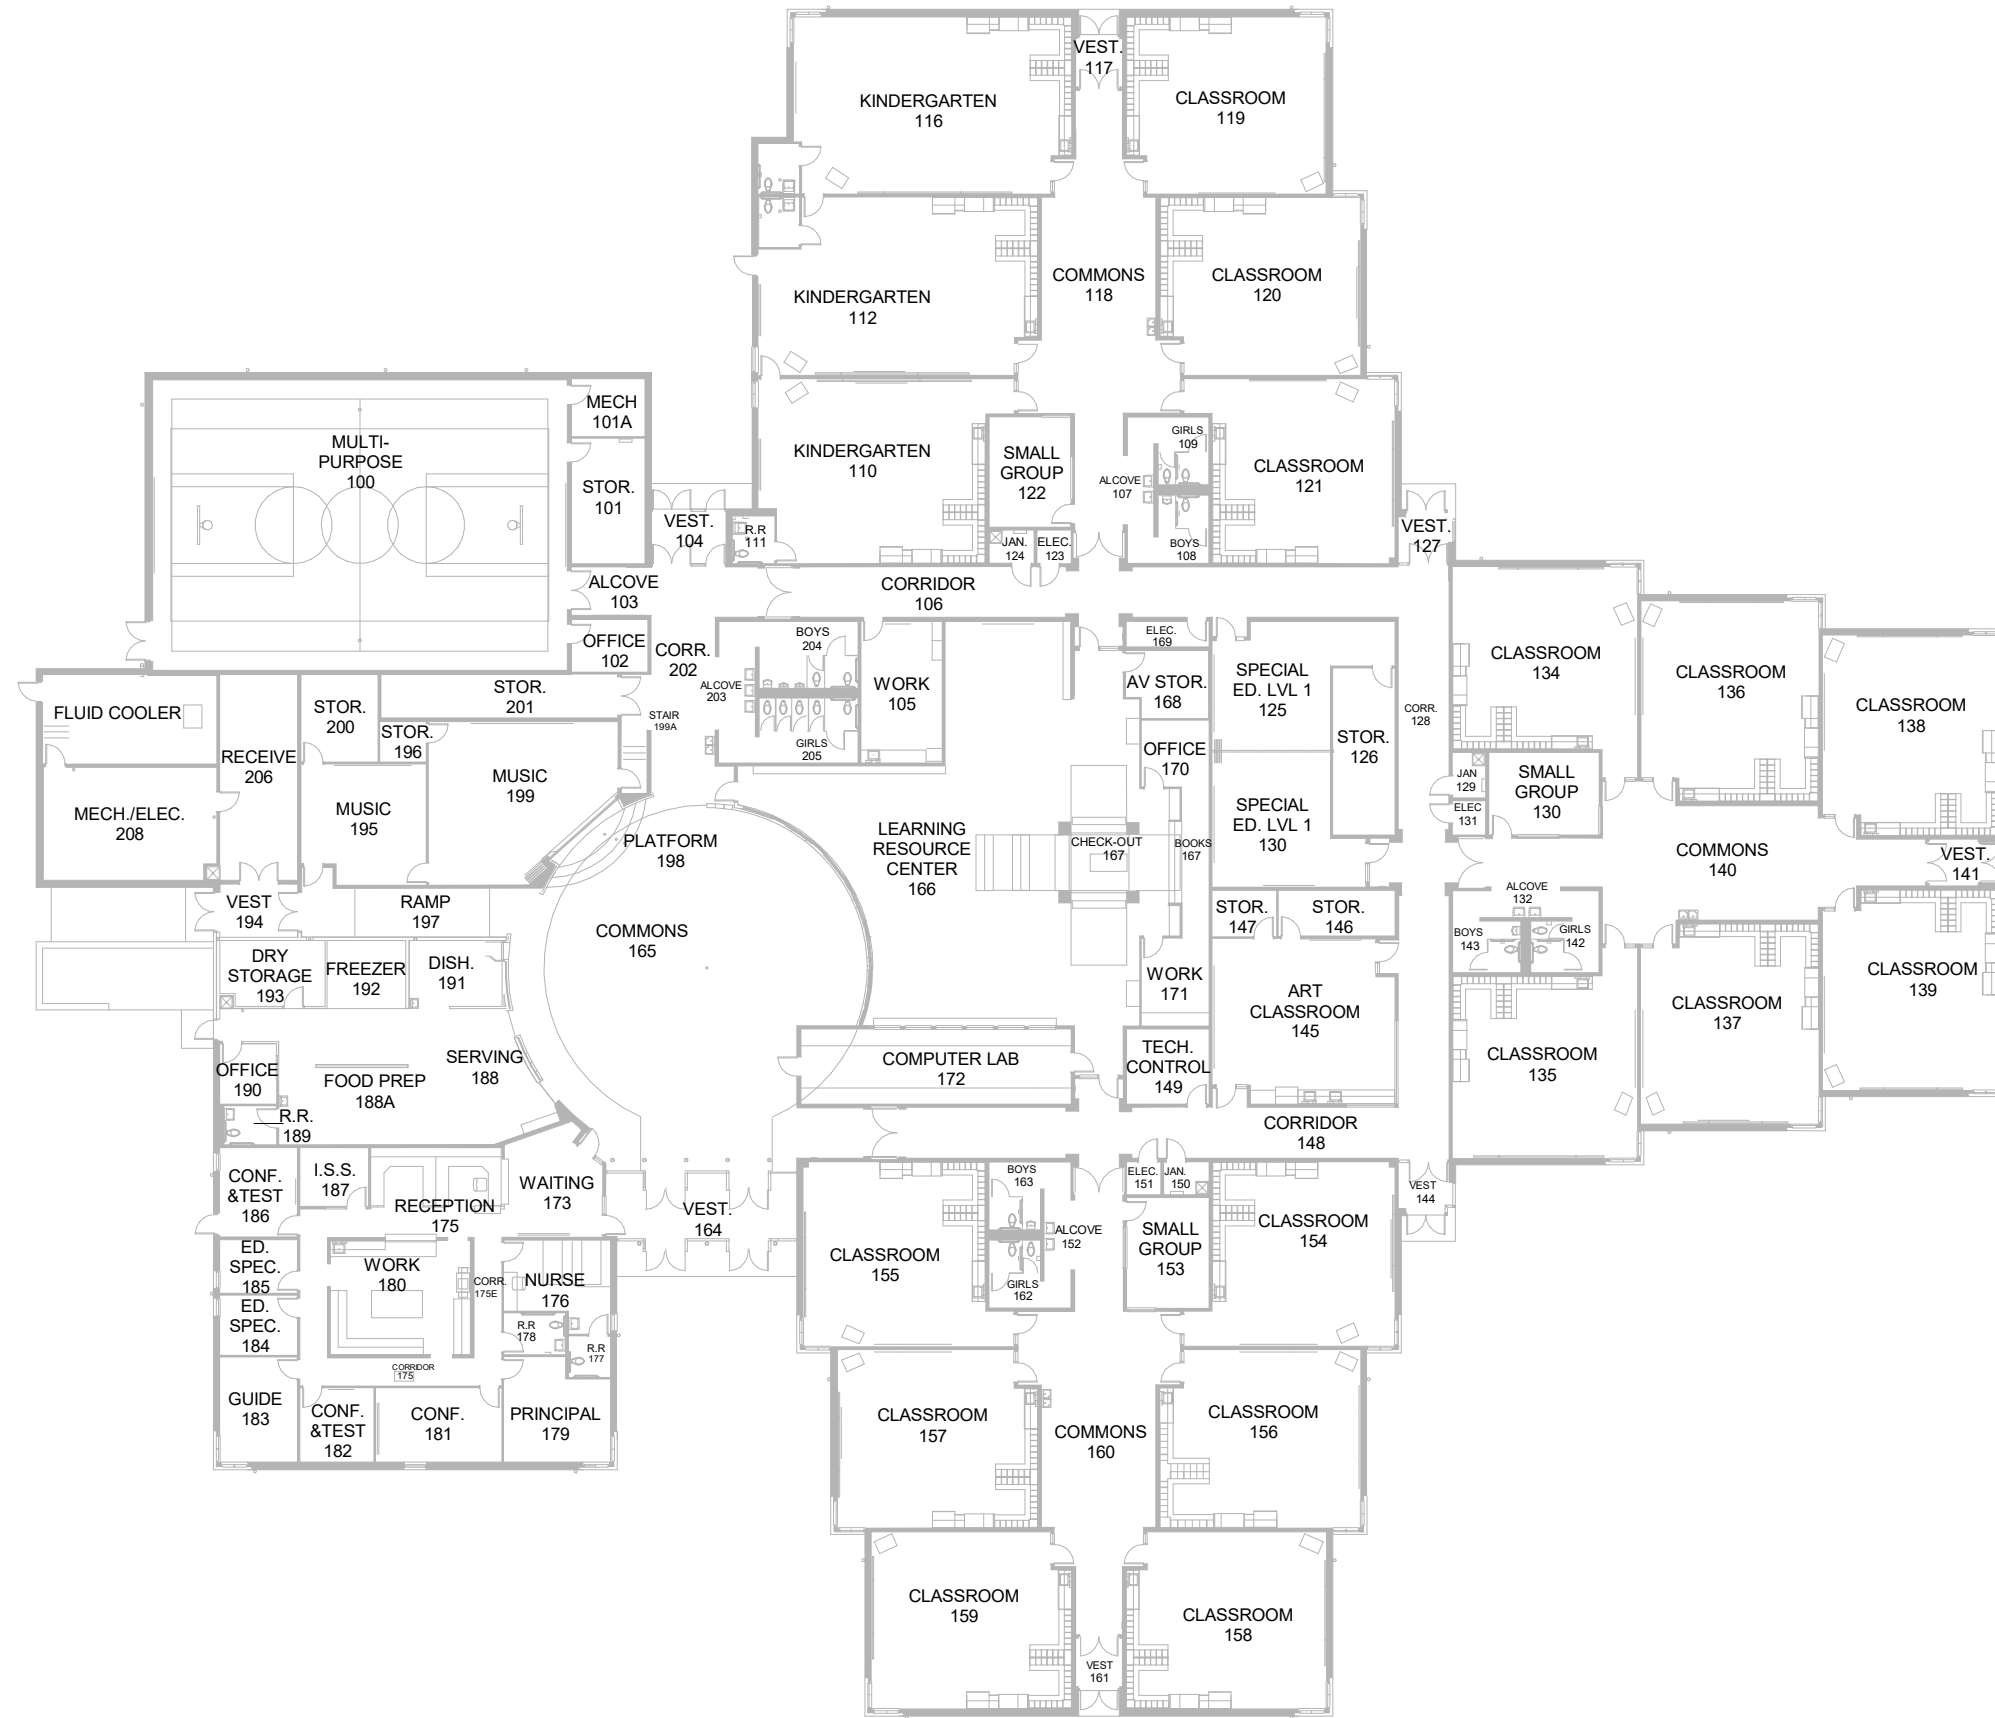
**BELL FIELD ELEMENTARY  
FIRST FLOOR PLAN**

- Kitchen is in very good condition overall and spaces are sized appropriately for their functions. School has receiving area, mop sink and employee restroom right in kitchen, unlike other elementary schools.
- Ovens and kettle may need to be replaced due to age.
- The Serving area is very small- recommend enlarging slightly if possible.
