Review of Building Conditions Assessment

# Board of Education Work Session

Dec 1, 2020

**November 2020**  
**BVH #19079**

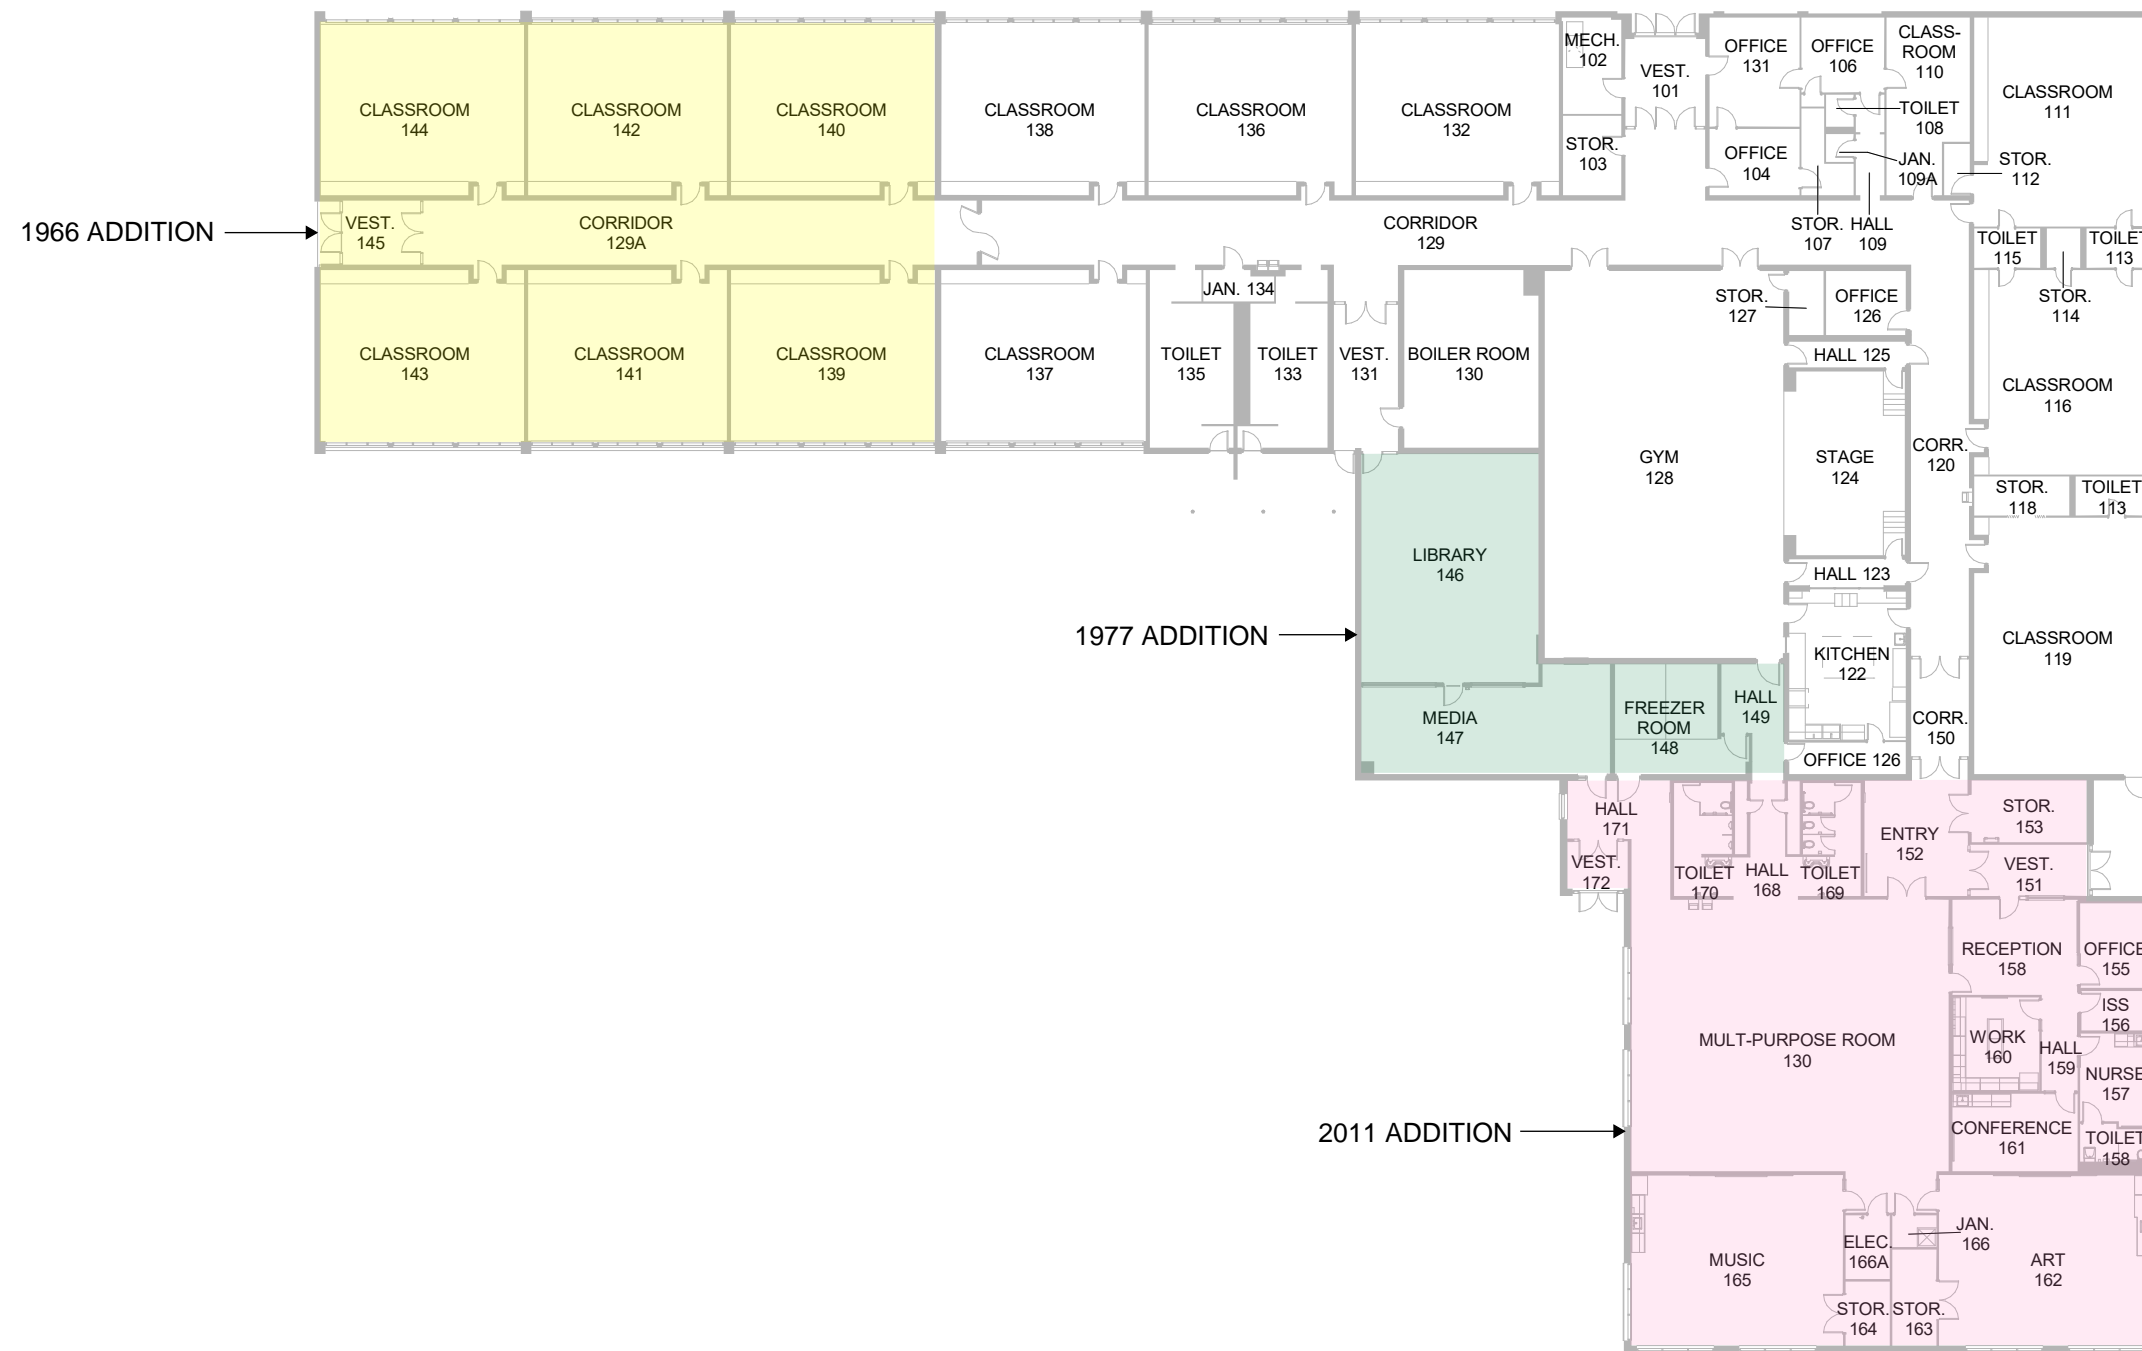
### 10. Kitchen

- Dry storage is in a narrow hallway / room with the water heater and janitorial equipment and should be relocated.
- Wood casework at serving line and wood prep table are not institutional grade or NSF certified, and should be replaced with stainless steel equipment. Painted steel hood does not meet current mechanical code.
- There is no prep sink in kitchen – one will need to be added to meet current health code.
- There is no direct access from this kitchen to receiving or trash areas. Kitchen staff should also have direct access to a mop sink and employee restroom per health code.
- Ovens and two-burner range may need to be replaced due to age.

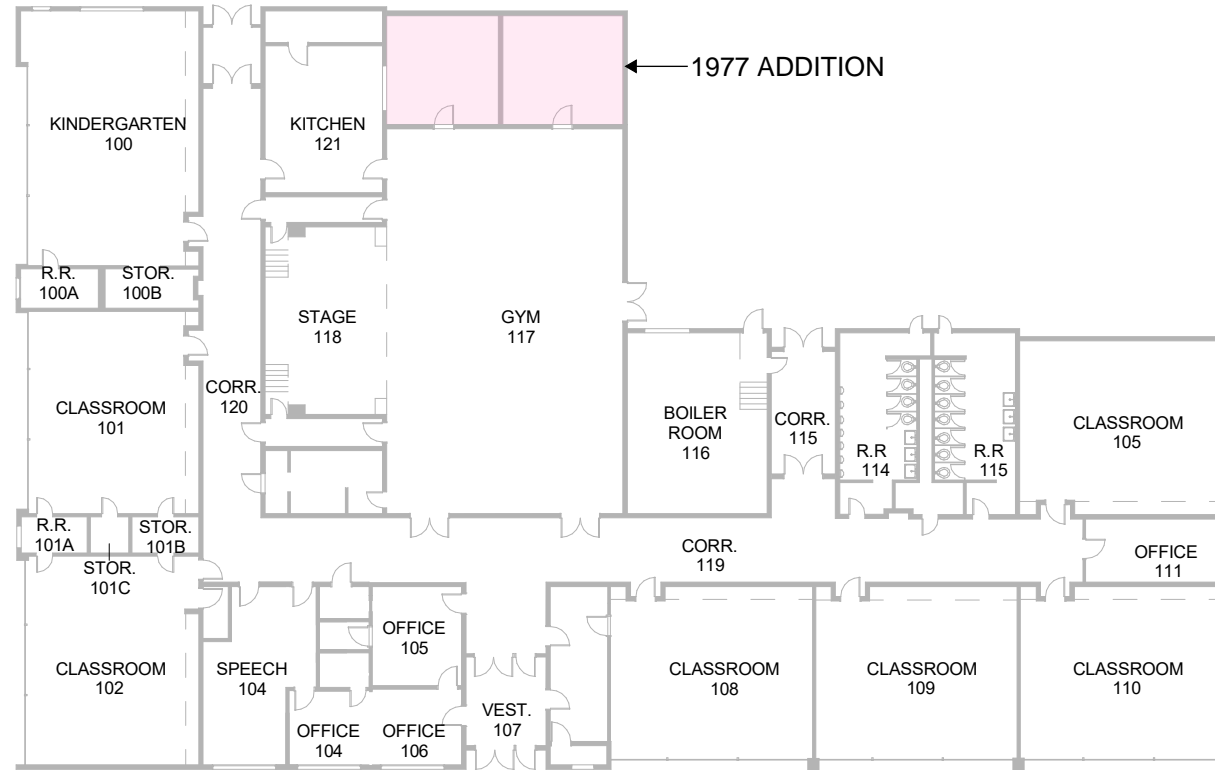
## **10. Kitchen**

- Wood cabinets at serving line and wood top tables are not institutional grade or NSF certified, and should be replaced with stainless steel equipment.
- No cookline equipment, was seen.
- Reach-in refrigerator appears to be very old.
- There is no prep sink in kitchen – one will need to be added to meet current health code.
- Kitchen staff should have direct access to a mop sink and employee restroom per health code.

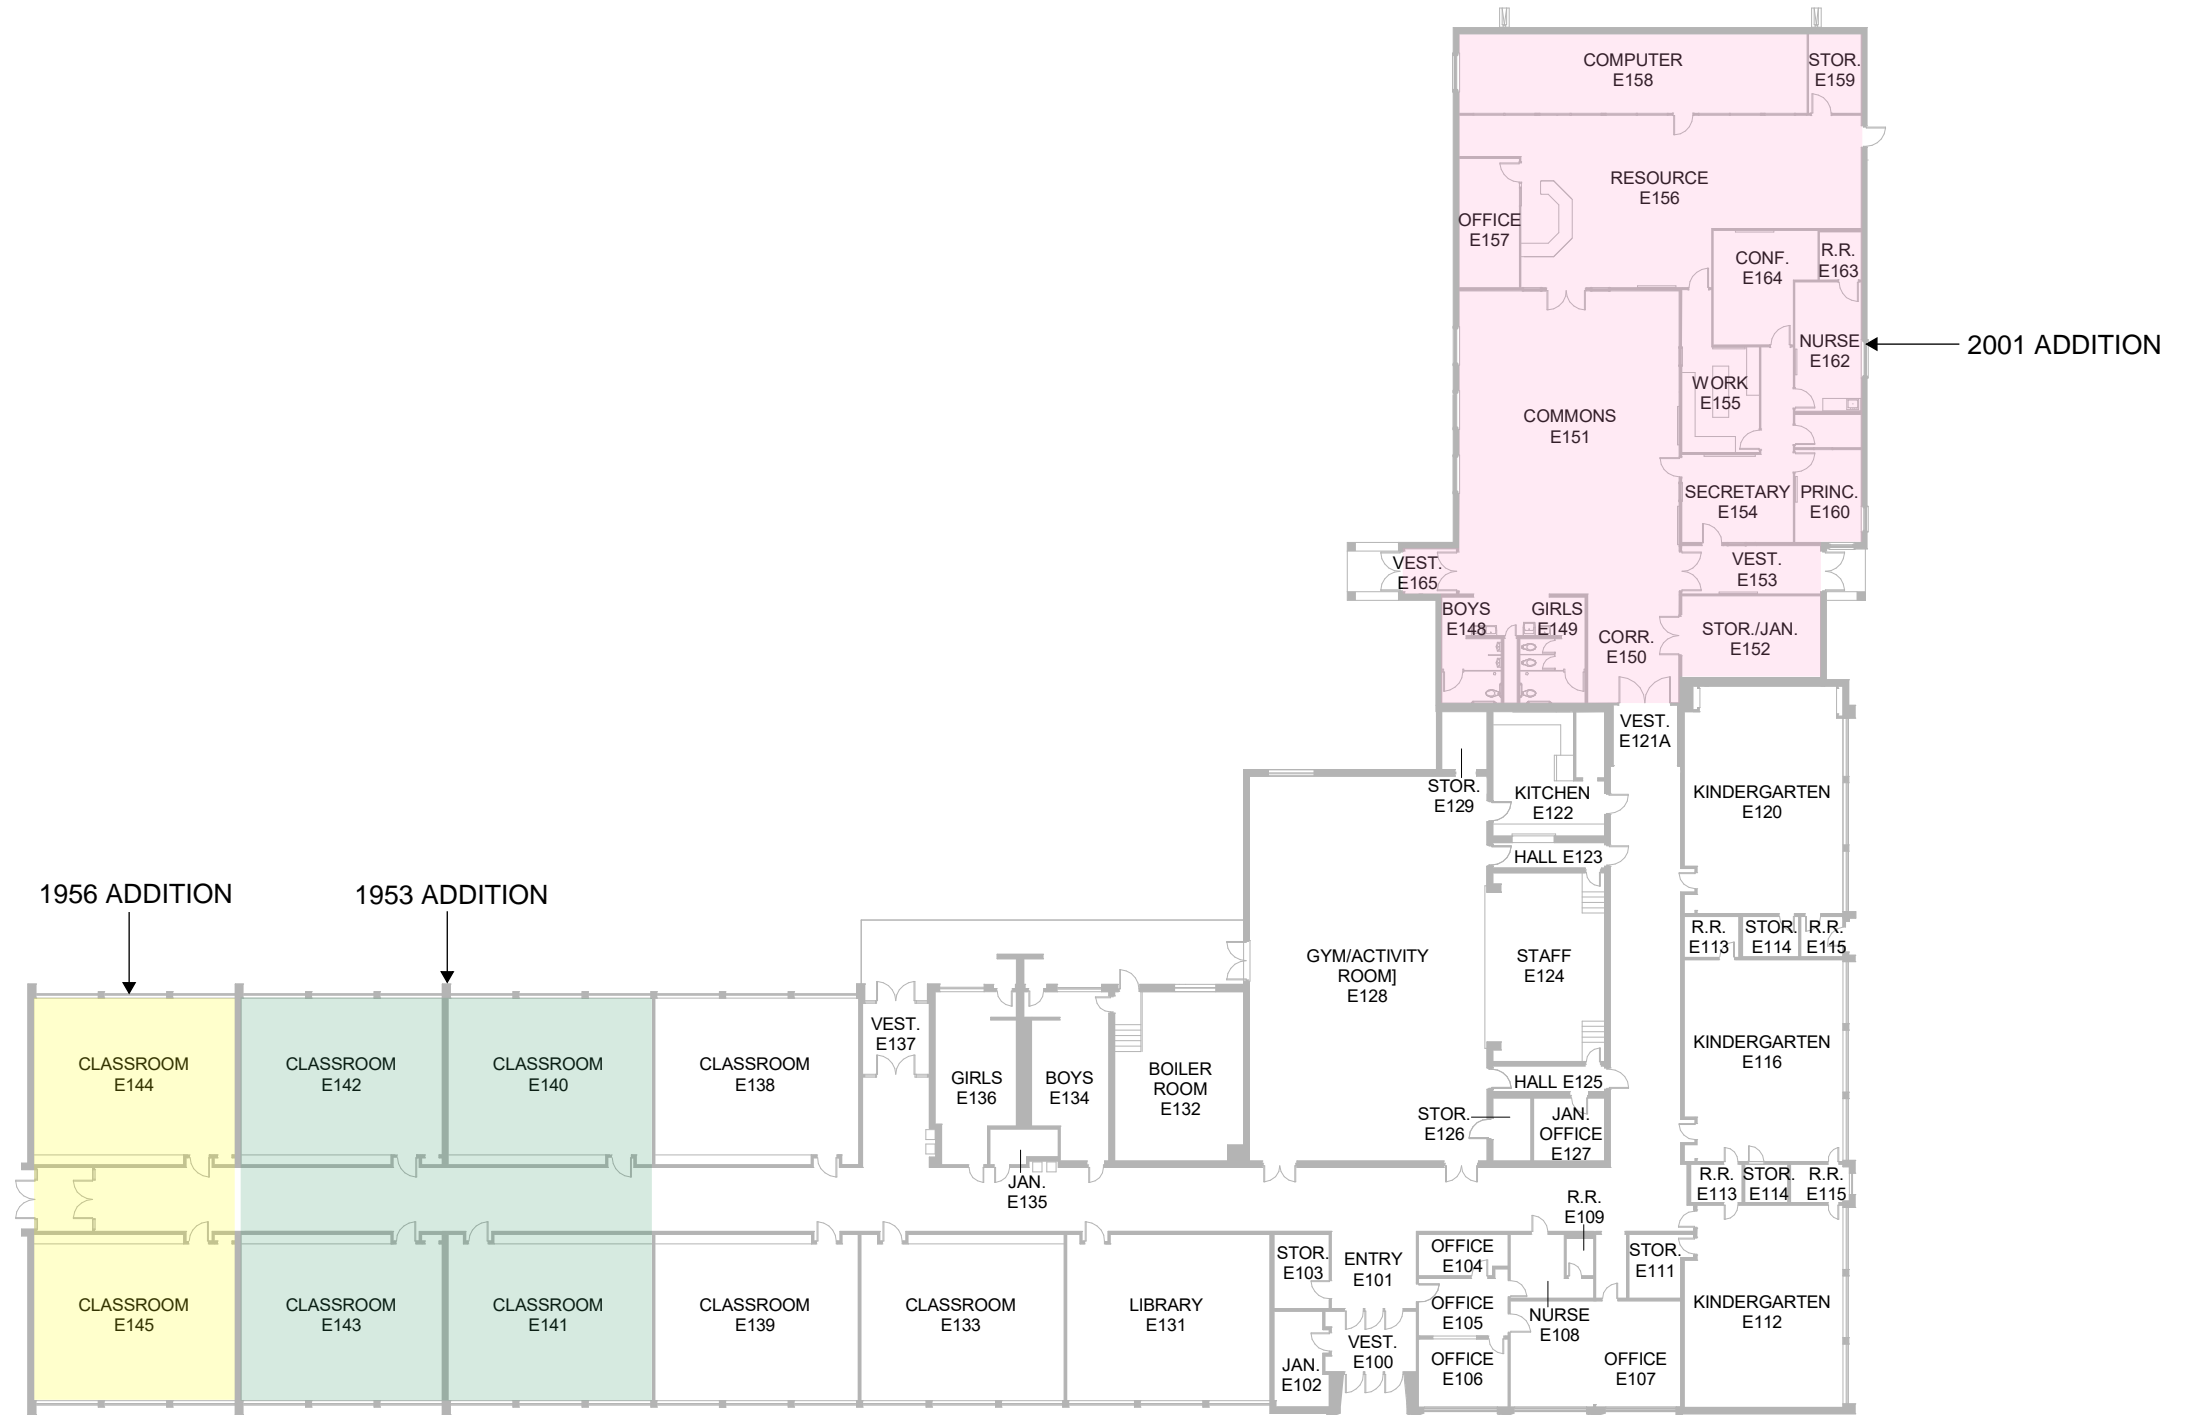
- There is no direct access from this kitchen to receiving or trash areas. Kitchen staff should also have direct access to a mop sink and employee restroom per health code.

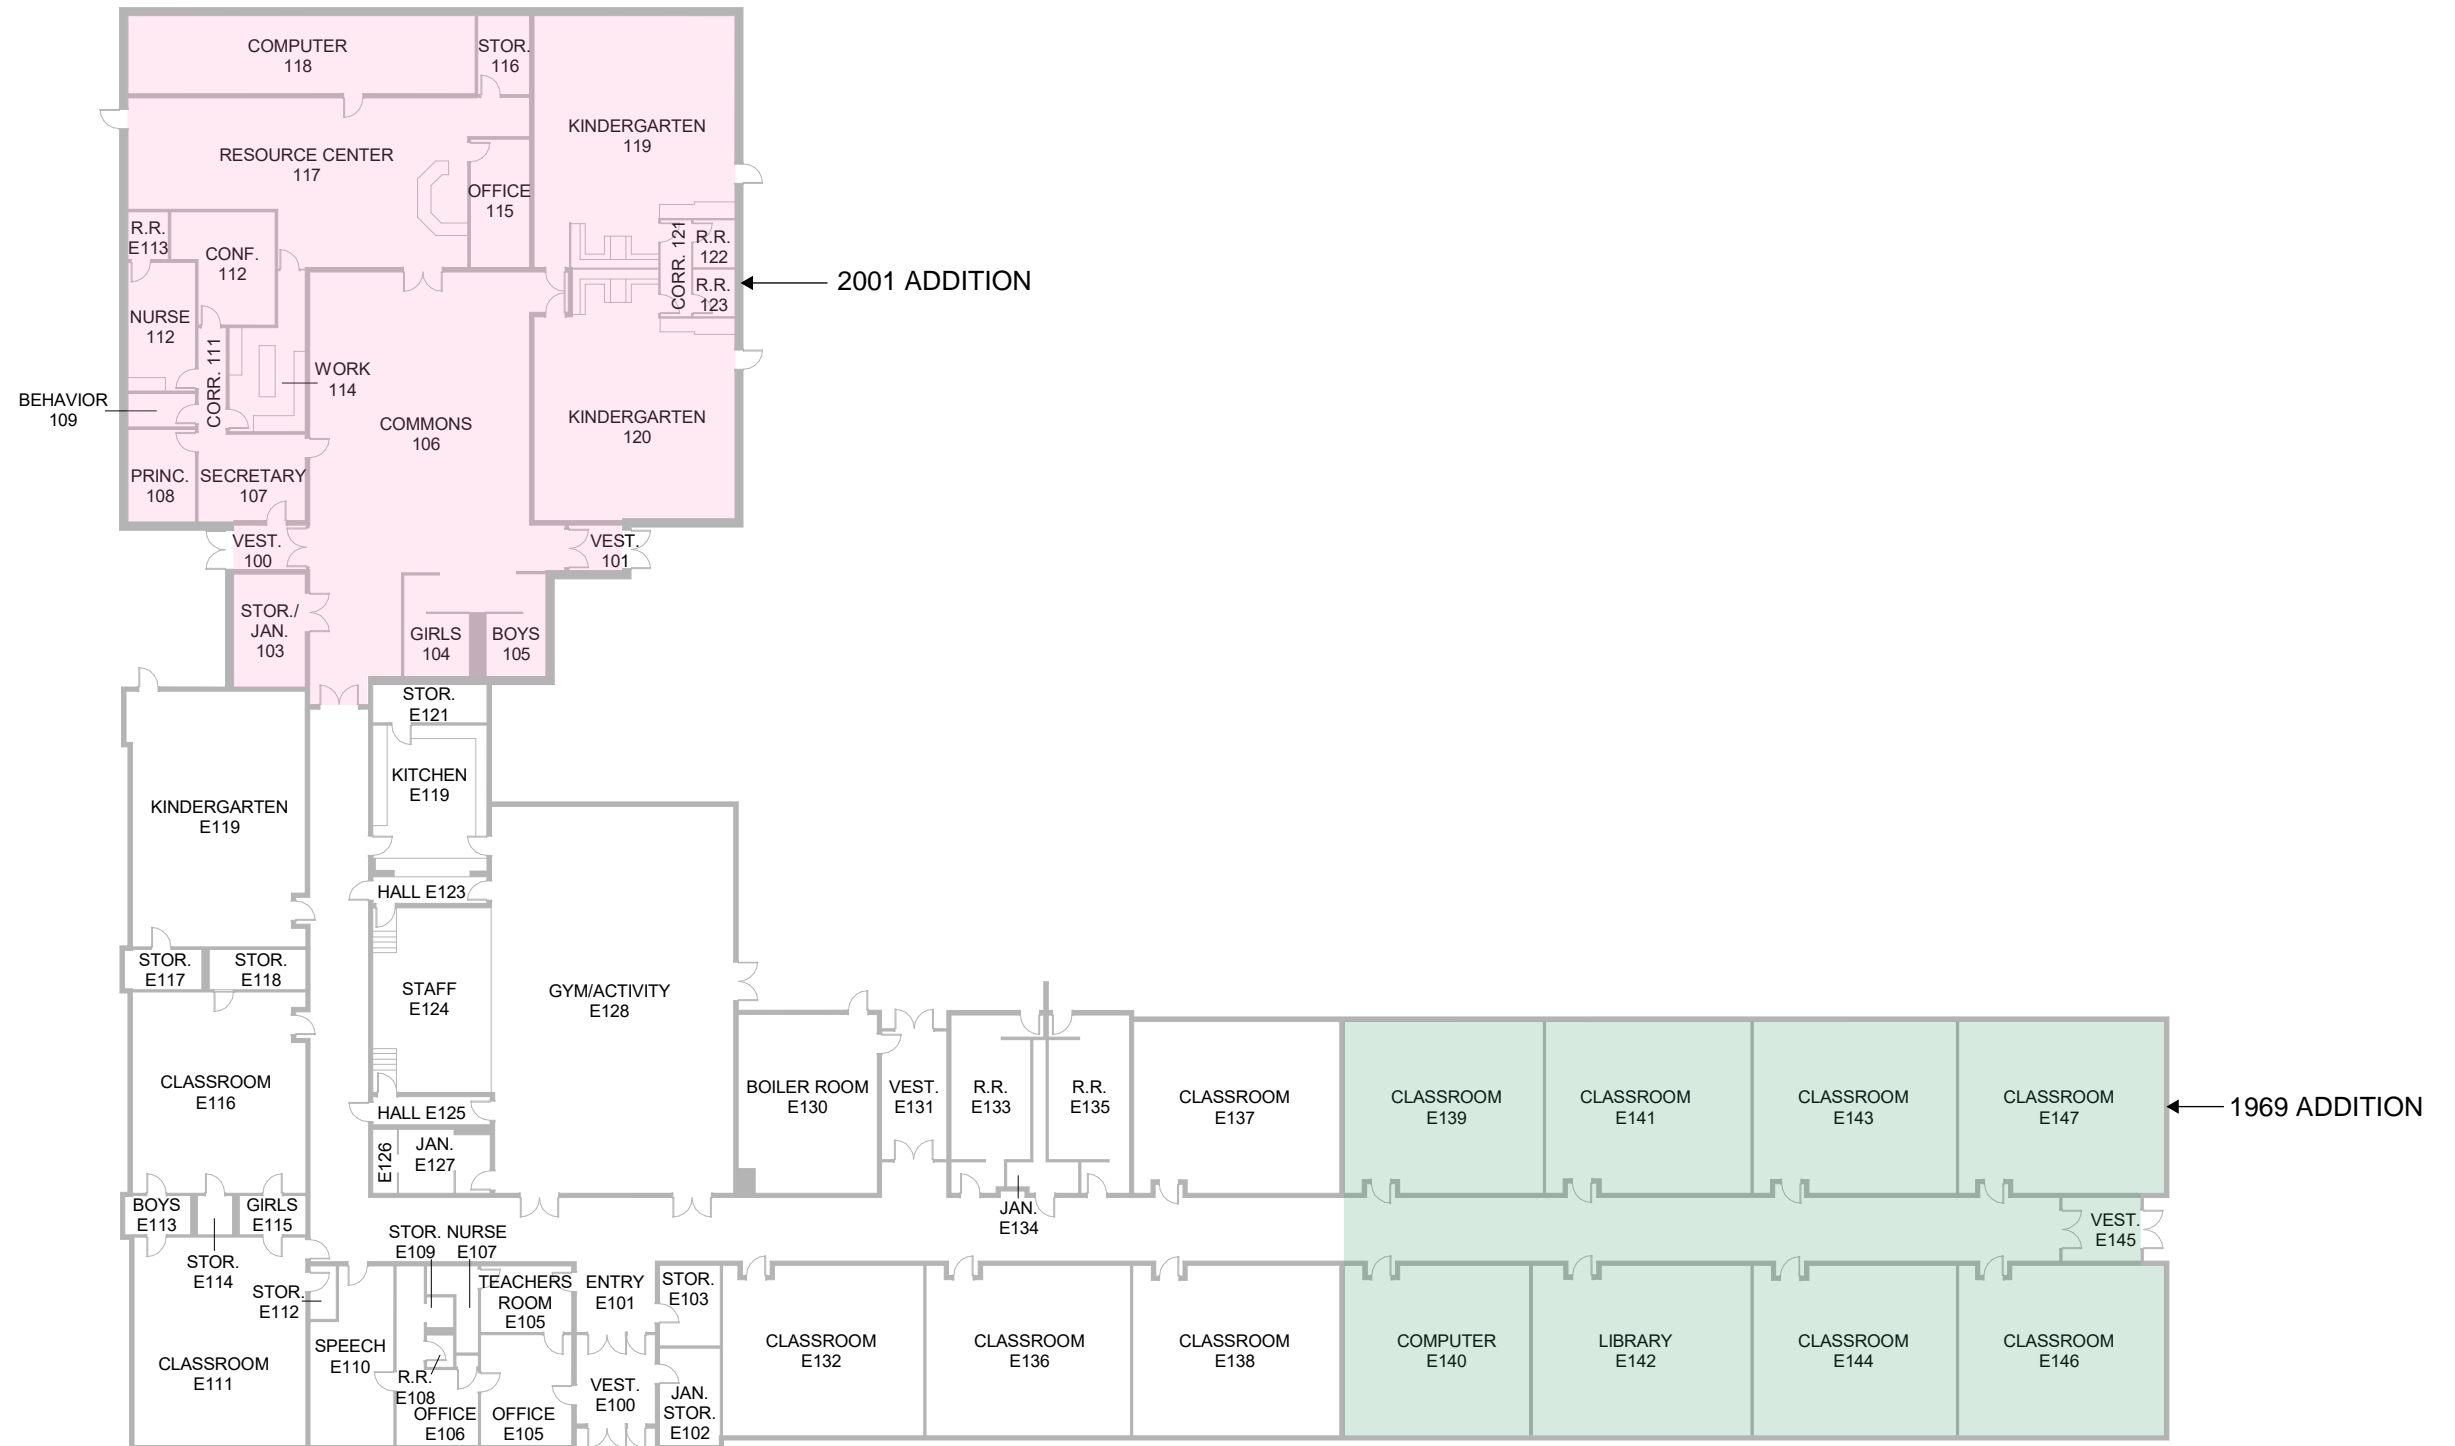
## **10. Kitchen**

- Prep tables and all wood casework should be replaced with institutional grade, NSF certified stainless steel equipment.
- There is no prep sink in kitchen – one will need to be added to meet current health code.
- Tray return and serving line wood casework should also be replaced with stainless steel equipment.
- There is no direct access from this kitchen to receiving or trash areas. Kitchen staff should also have direct access to a mop sink and employee restroom per health code

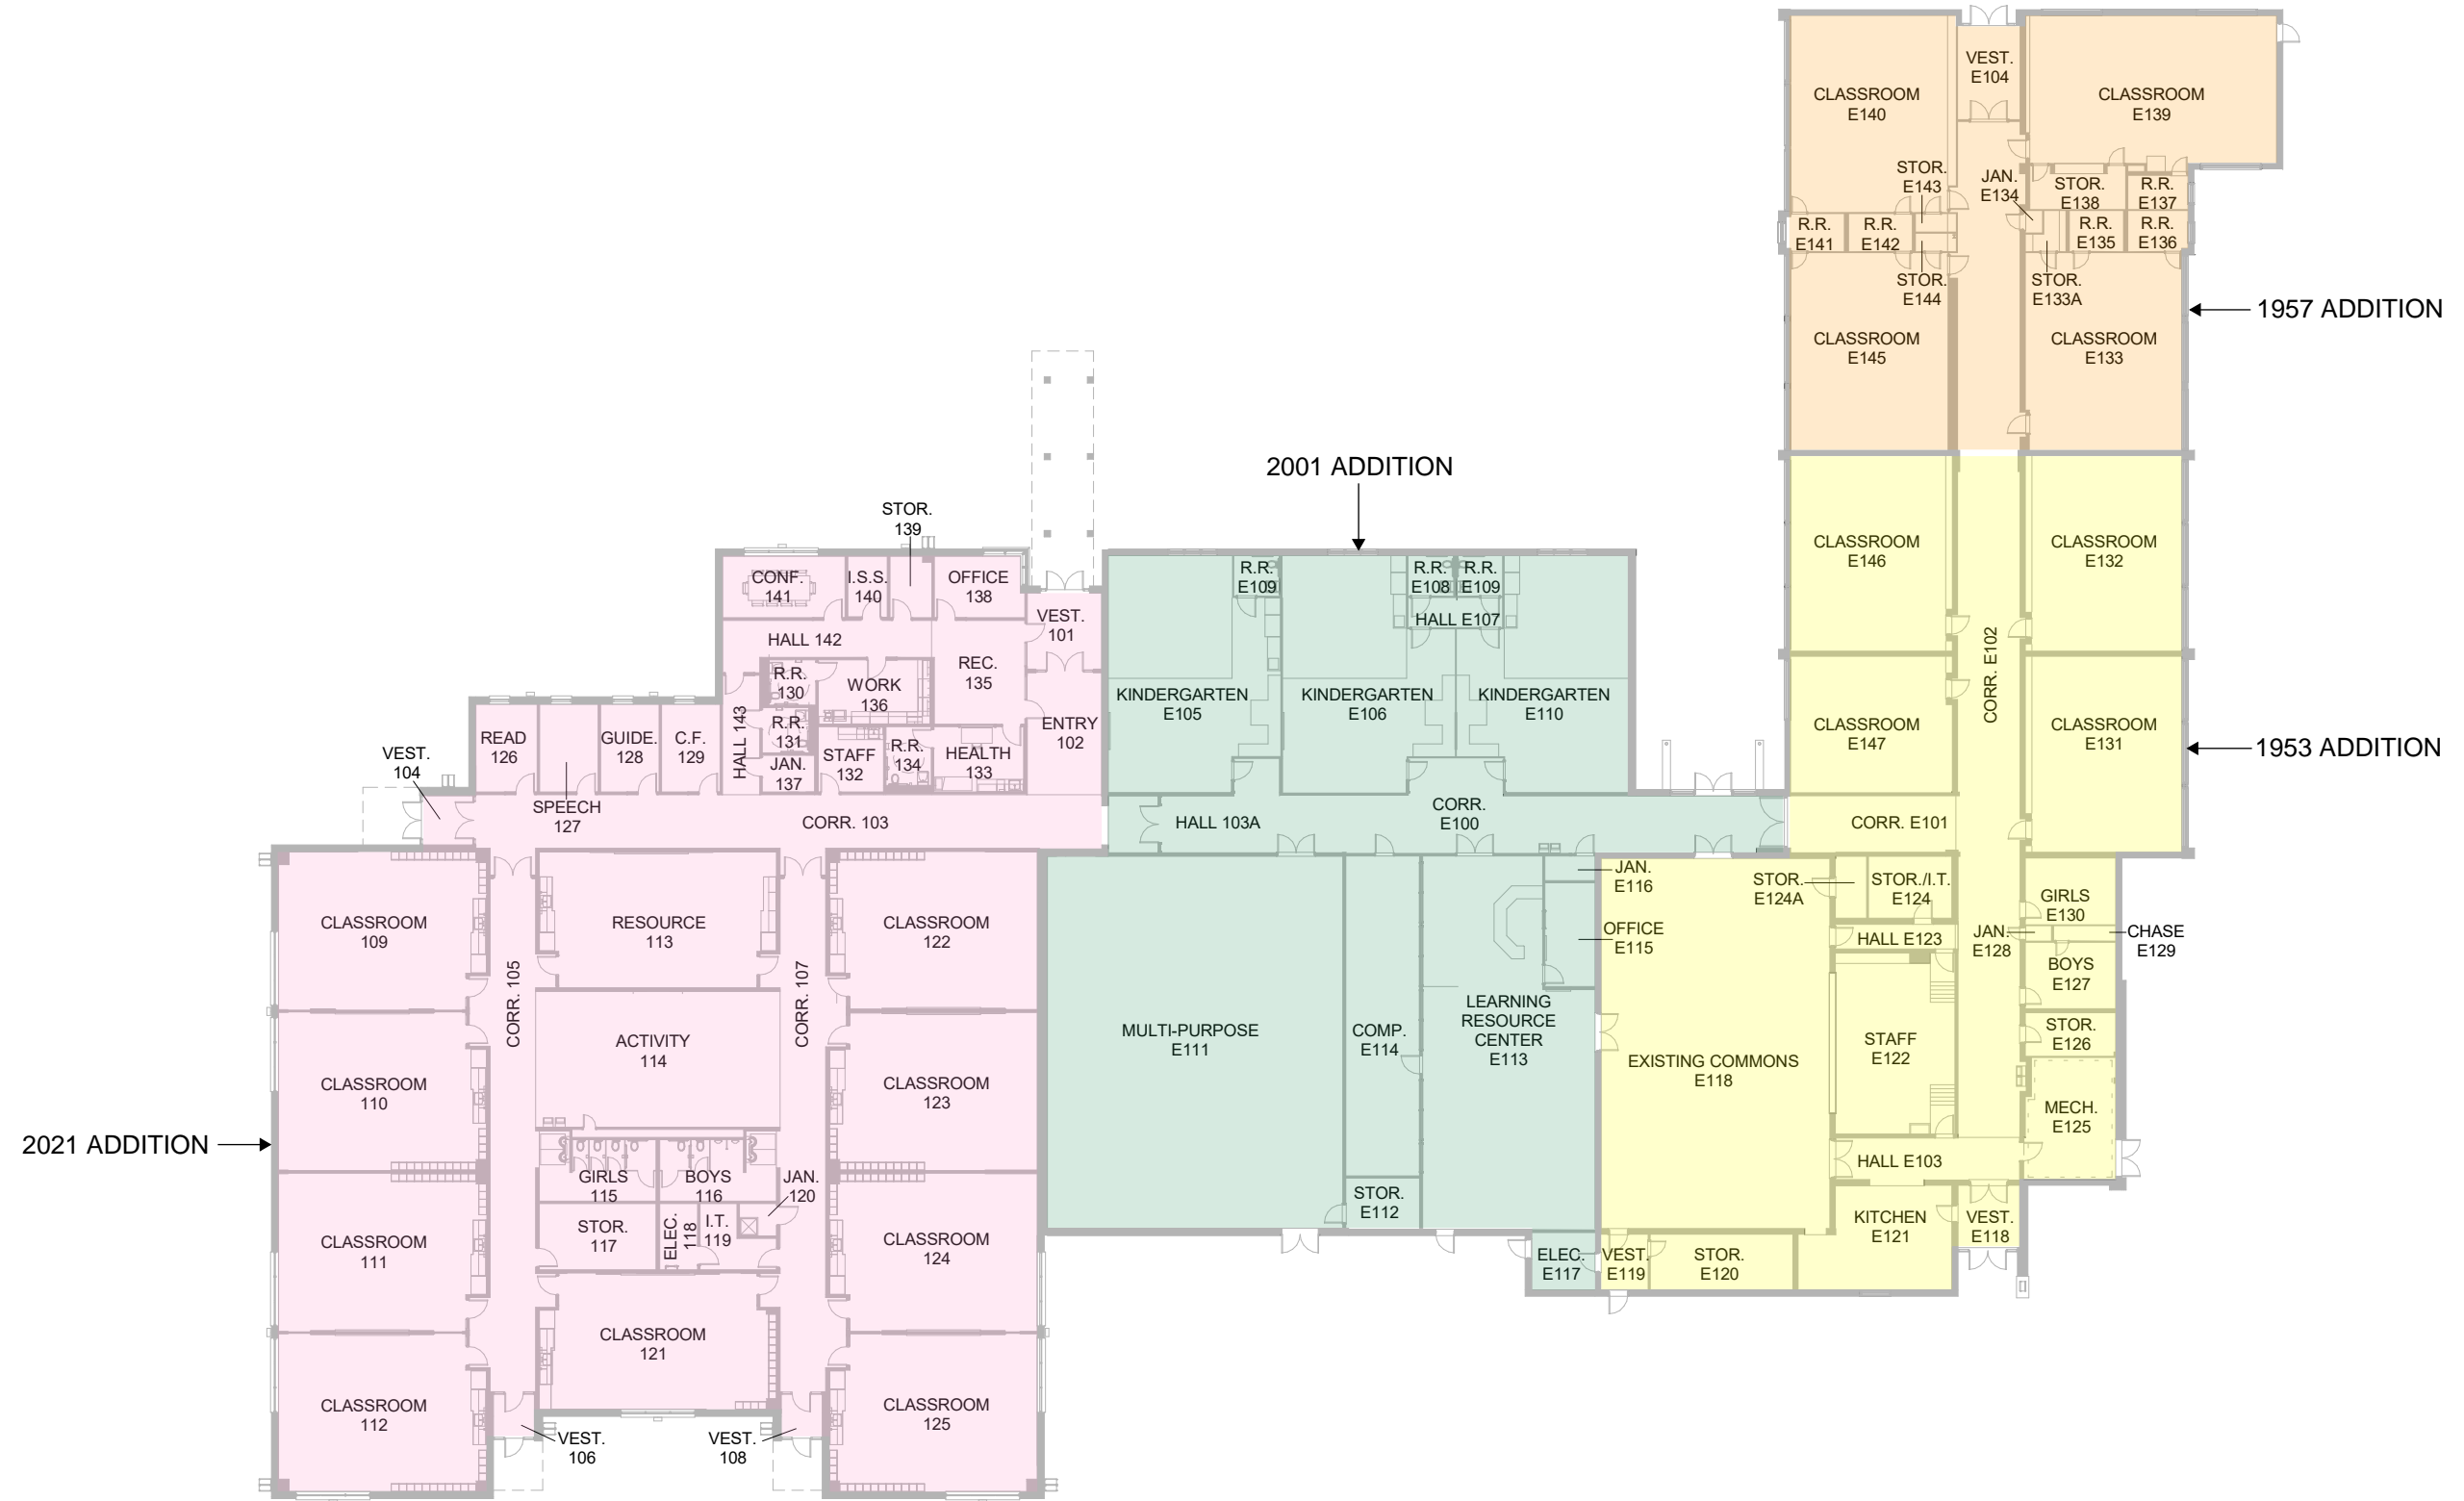
- Ovens and range may need to be replaced due to age. Refrigerator and kettle block electrical panel and disconnect switch – equipment must be moved to allow clearance and access to panel and disconnect.
- Exposed conduit and ductwork on walls and ceiling ideally should be concealed to prevent dust and dirt from collecting on these surfaces.
- There is no prep sink in the kitchen – one will need to be added to meet current health code.

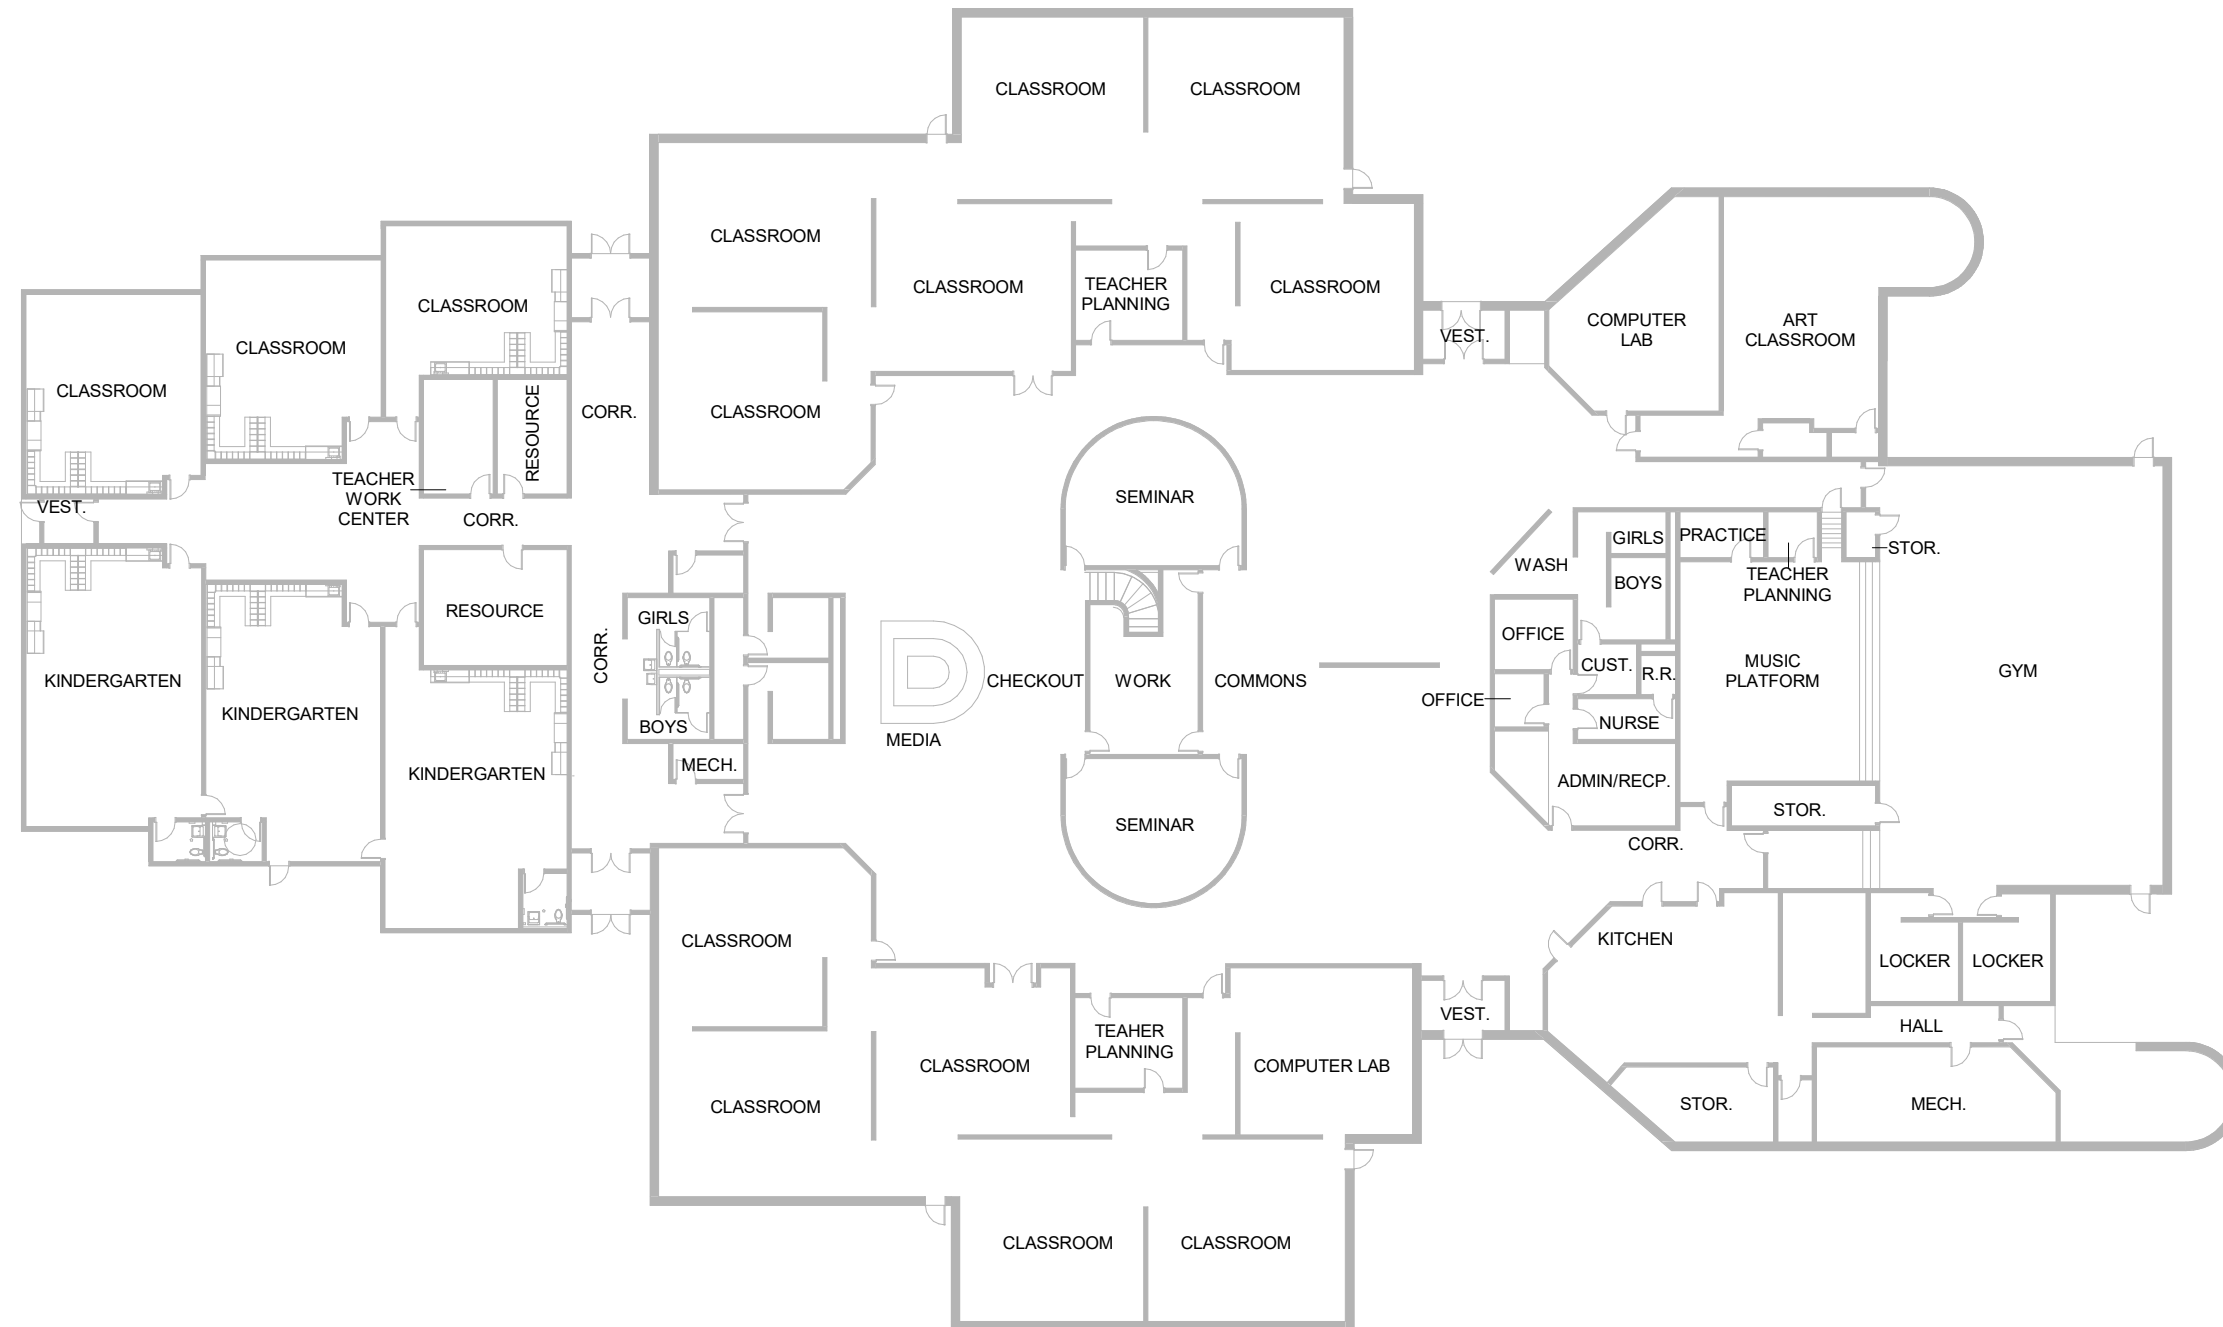
### 10. Kitchen

- Prep table with wood legs and laminate top is not institutional grade or NSF certified and should be replaced with a stainless steel table.
- Serving Line appears functional, but the painted finish is chipping on the rear sliding doors.
- Receiving dock and stairs are crumbling and should be repaired or replaced.
- Some ceiling tiles are sagging and need to be replaced.
- Janitorial supplies should be separated from Dry Storage and should be in a secured area.

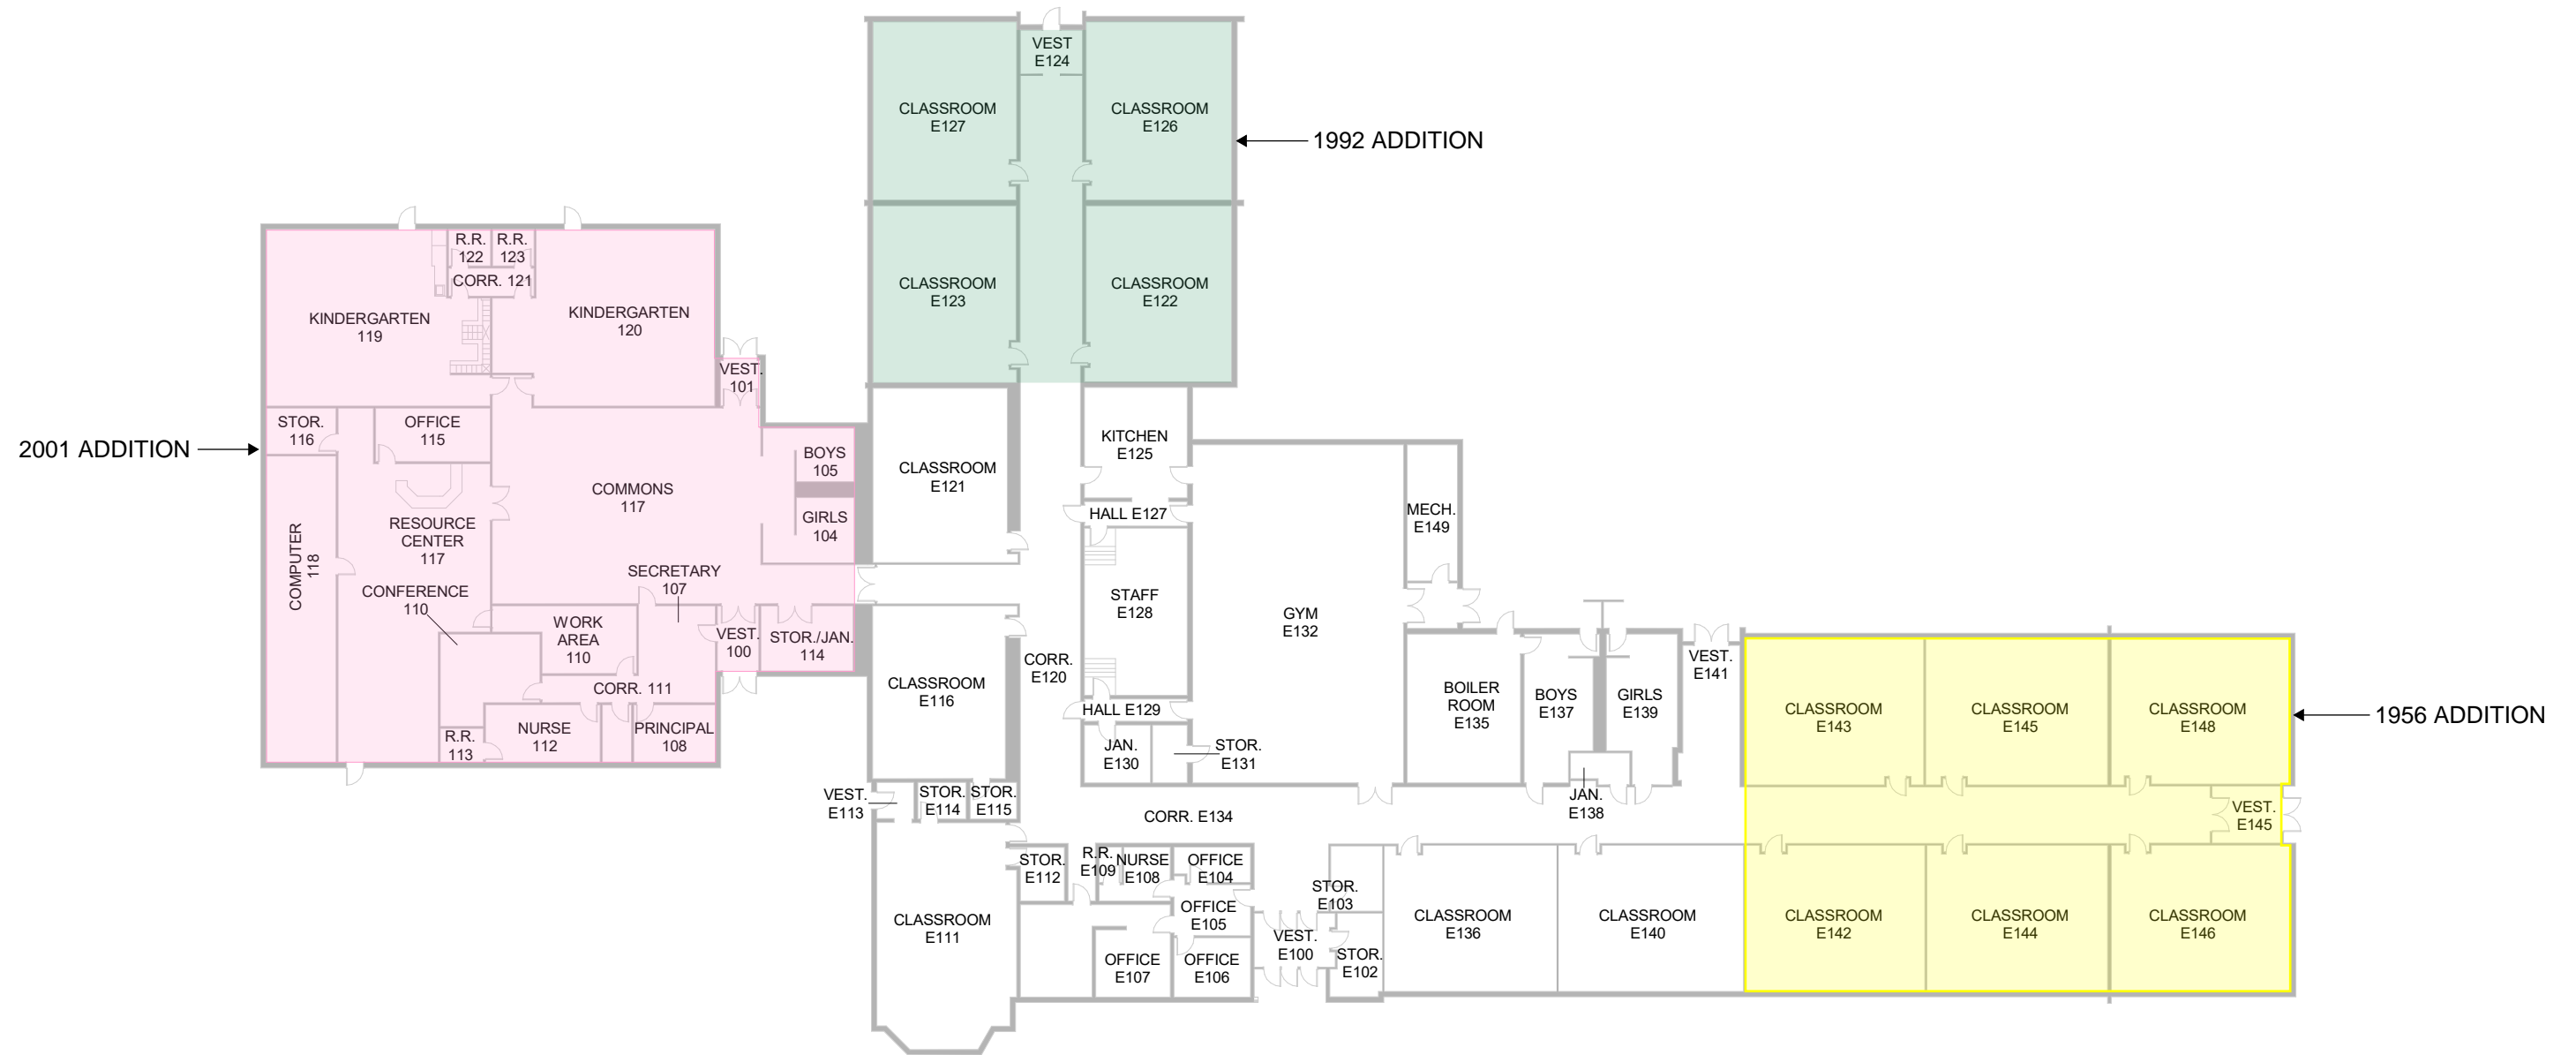
- Dry storage is currently beneath the exhaust hood and needs to be relocated.
- Main electrical panel is right next to hand sink.
- There is no prep sink in kitchen – one will need to be added to meet current health code.

- Exposed conduit and ductwork on walls and ceiling ideally should be concealed to prevent dust and dirt from collecting on these surfaces.
- There is no direct access from this kitchen to receiving or trash areas. Kitchen staff should also have direct access to a mop sink and employee restroom per health code.
