Review of Building Conditions Assessment

# Board of Education Work Session

Dec 1, 2020

**November 2020**  
**BVH #19079**

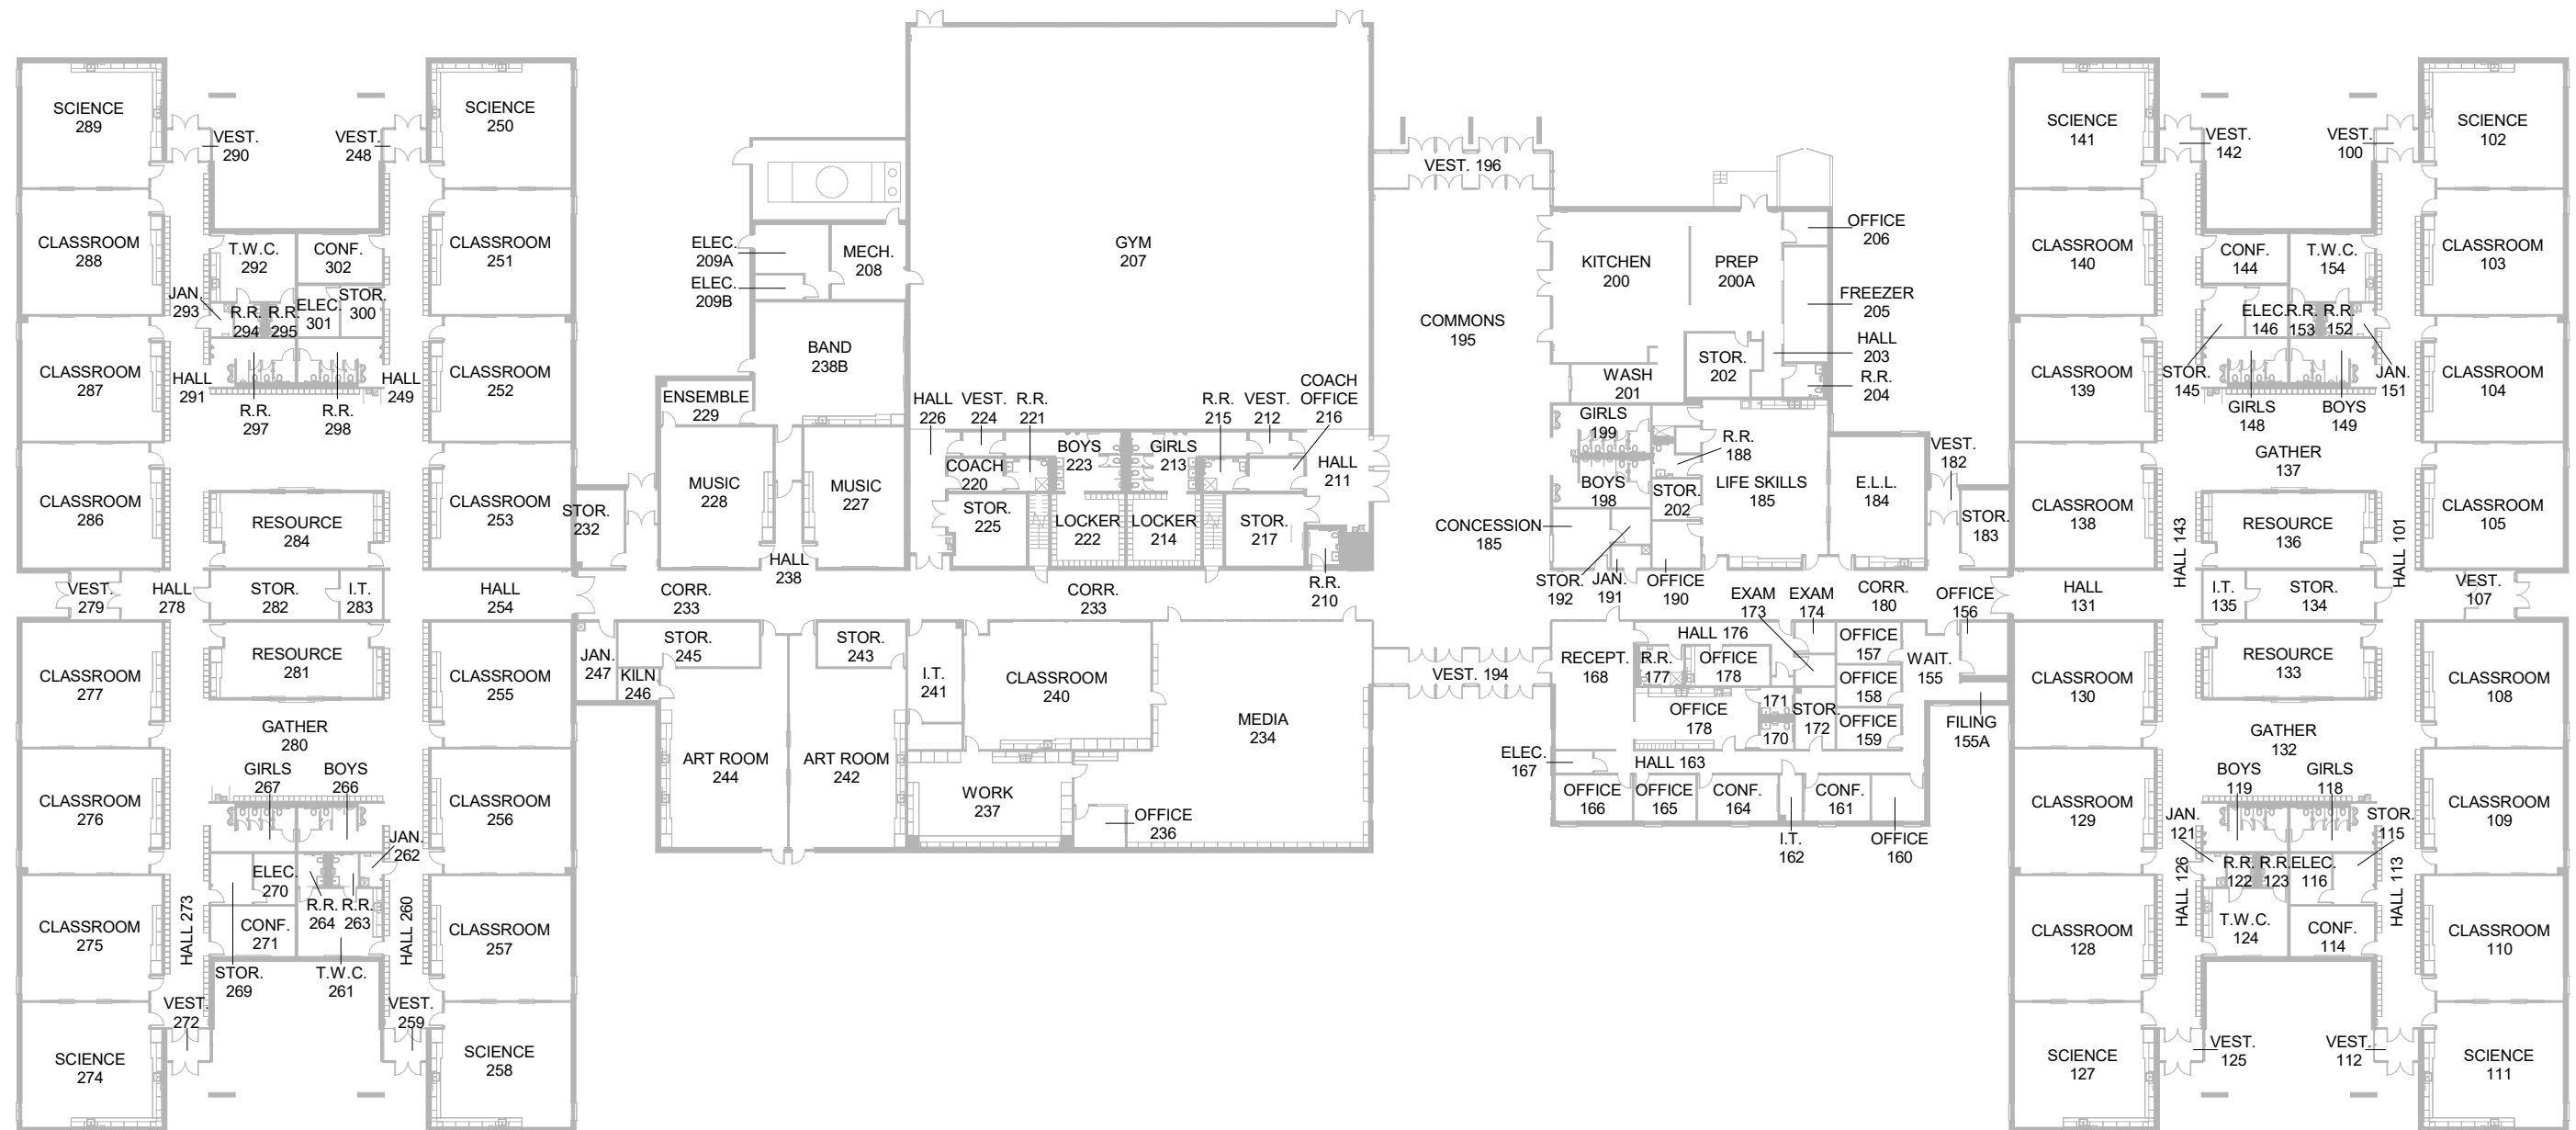
**10. Kitchen**

- This school generally is in great condition with the appropriate square footage for the various functions.
- The Warewash area is in the greatest need of some upkeep/repair.
  - The four-compartment sink and dishtables need to be re-caulked to the wall.
  - Dishmachine needs to be delimed in areas, and the clean dishtable needs to be readjusted for the proper slope.
  - With some cleaning and maintenance all of these items will be in usable condition.

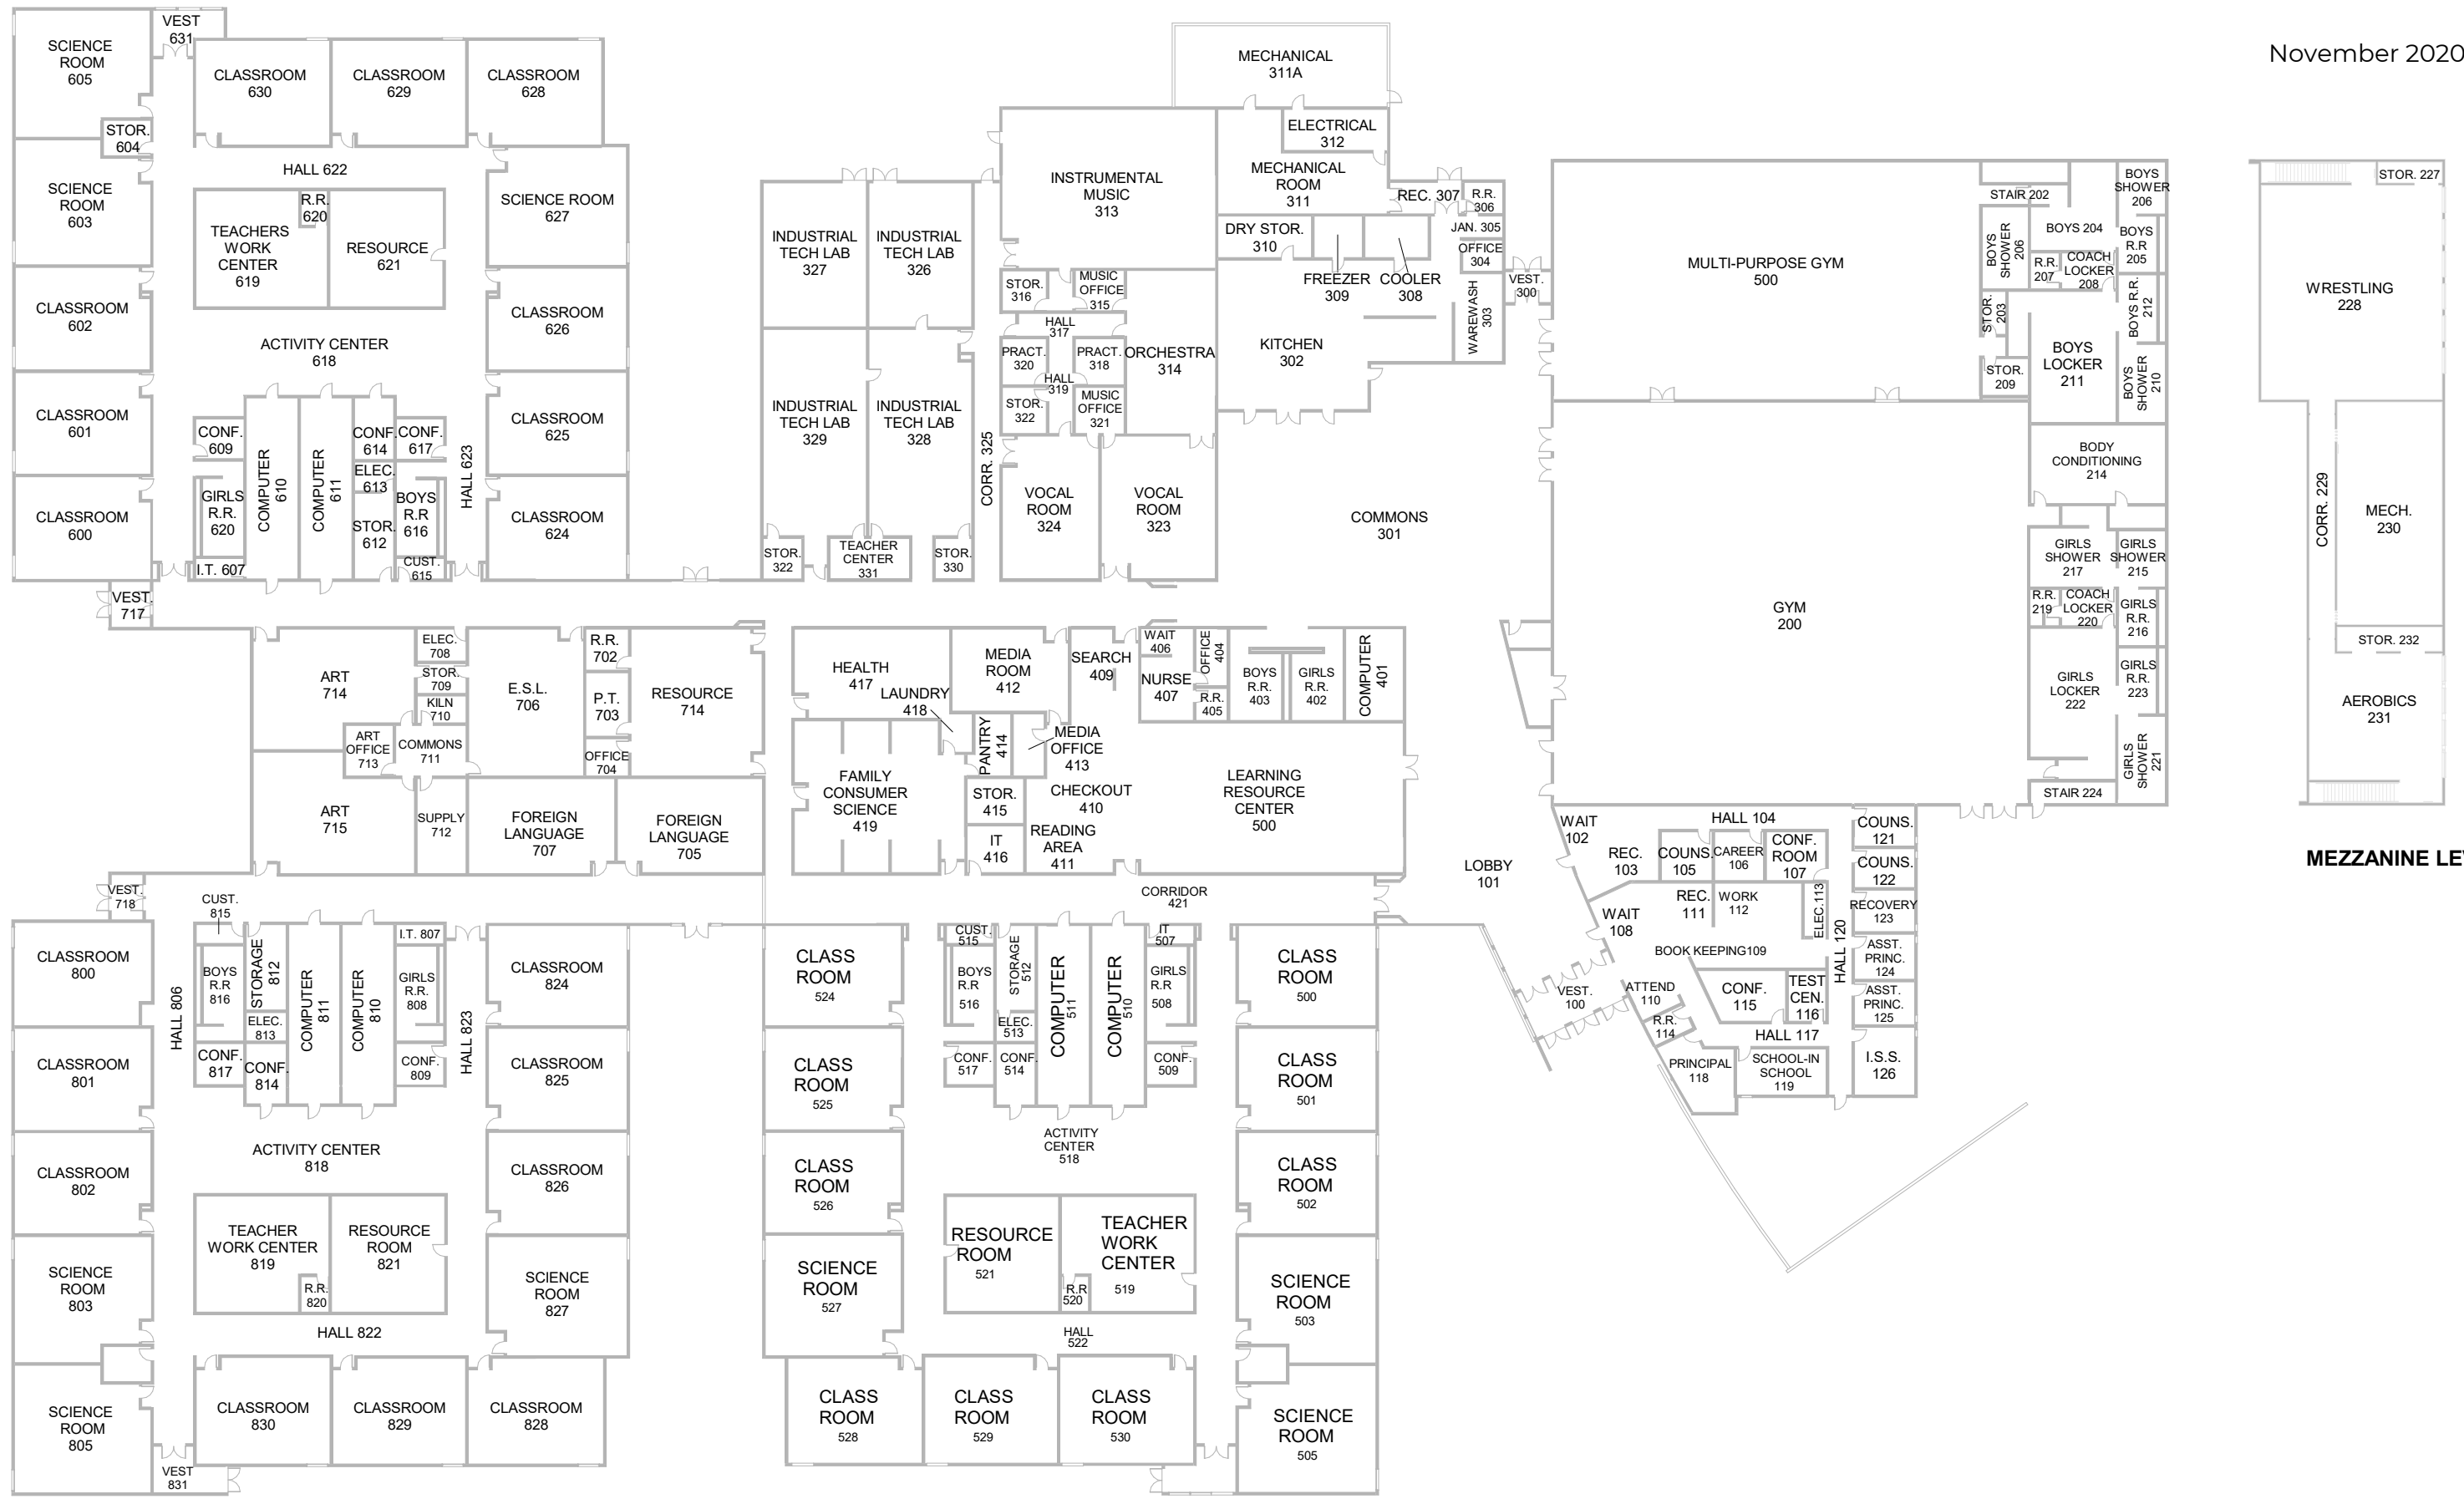
**10. Kitchen**

- Serving line circulation is tight. A few prep tables have galvanized bases that should be replaced.
- Ceiling tiles around dishmachine pant-leg vents need to be replaced. Dishmachine looks as if it may need some maintenance.
- The rest of the kitchen areas and equipment are in good condition.

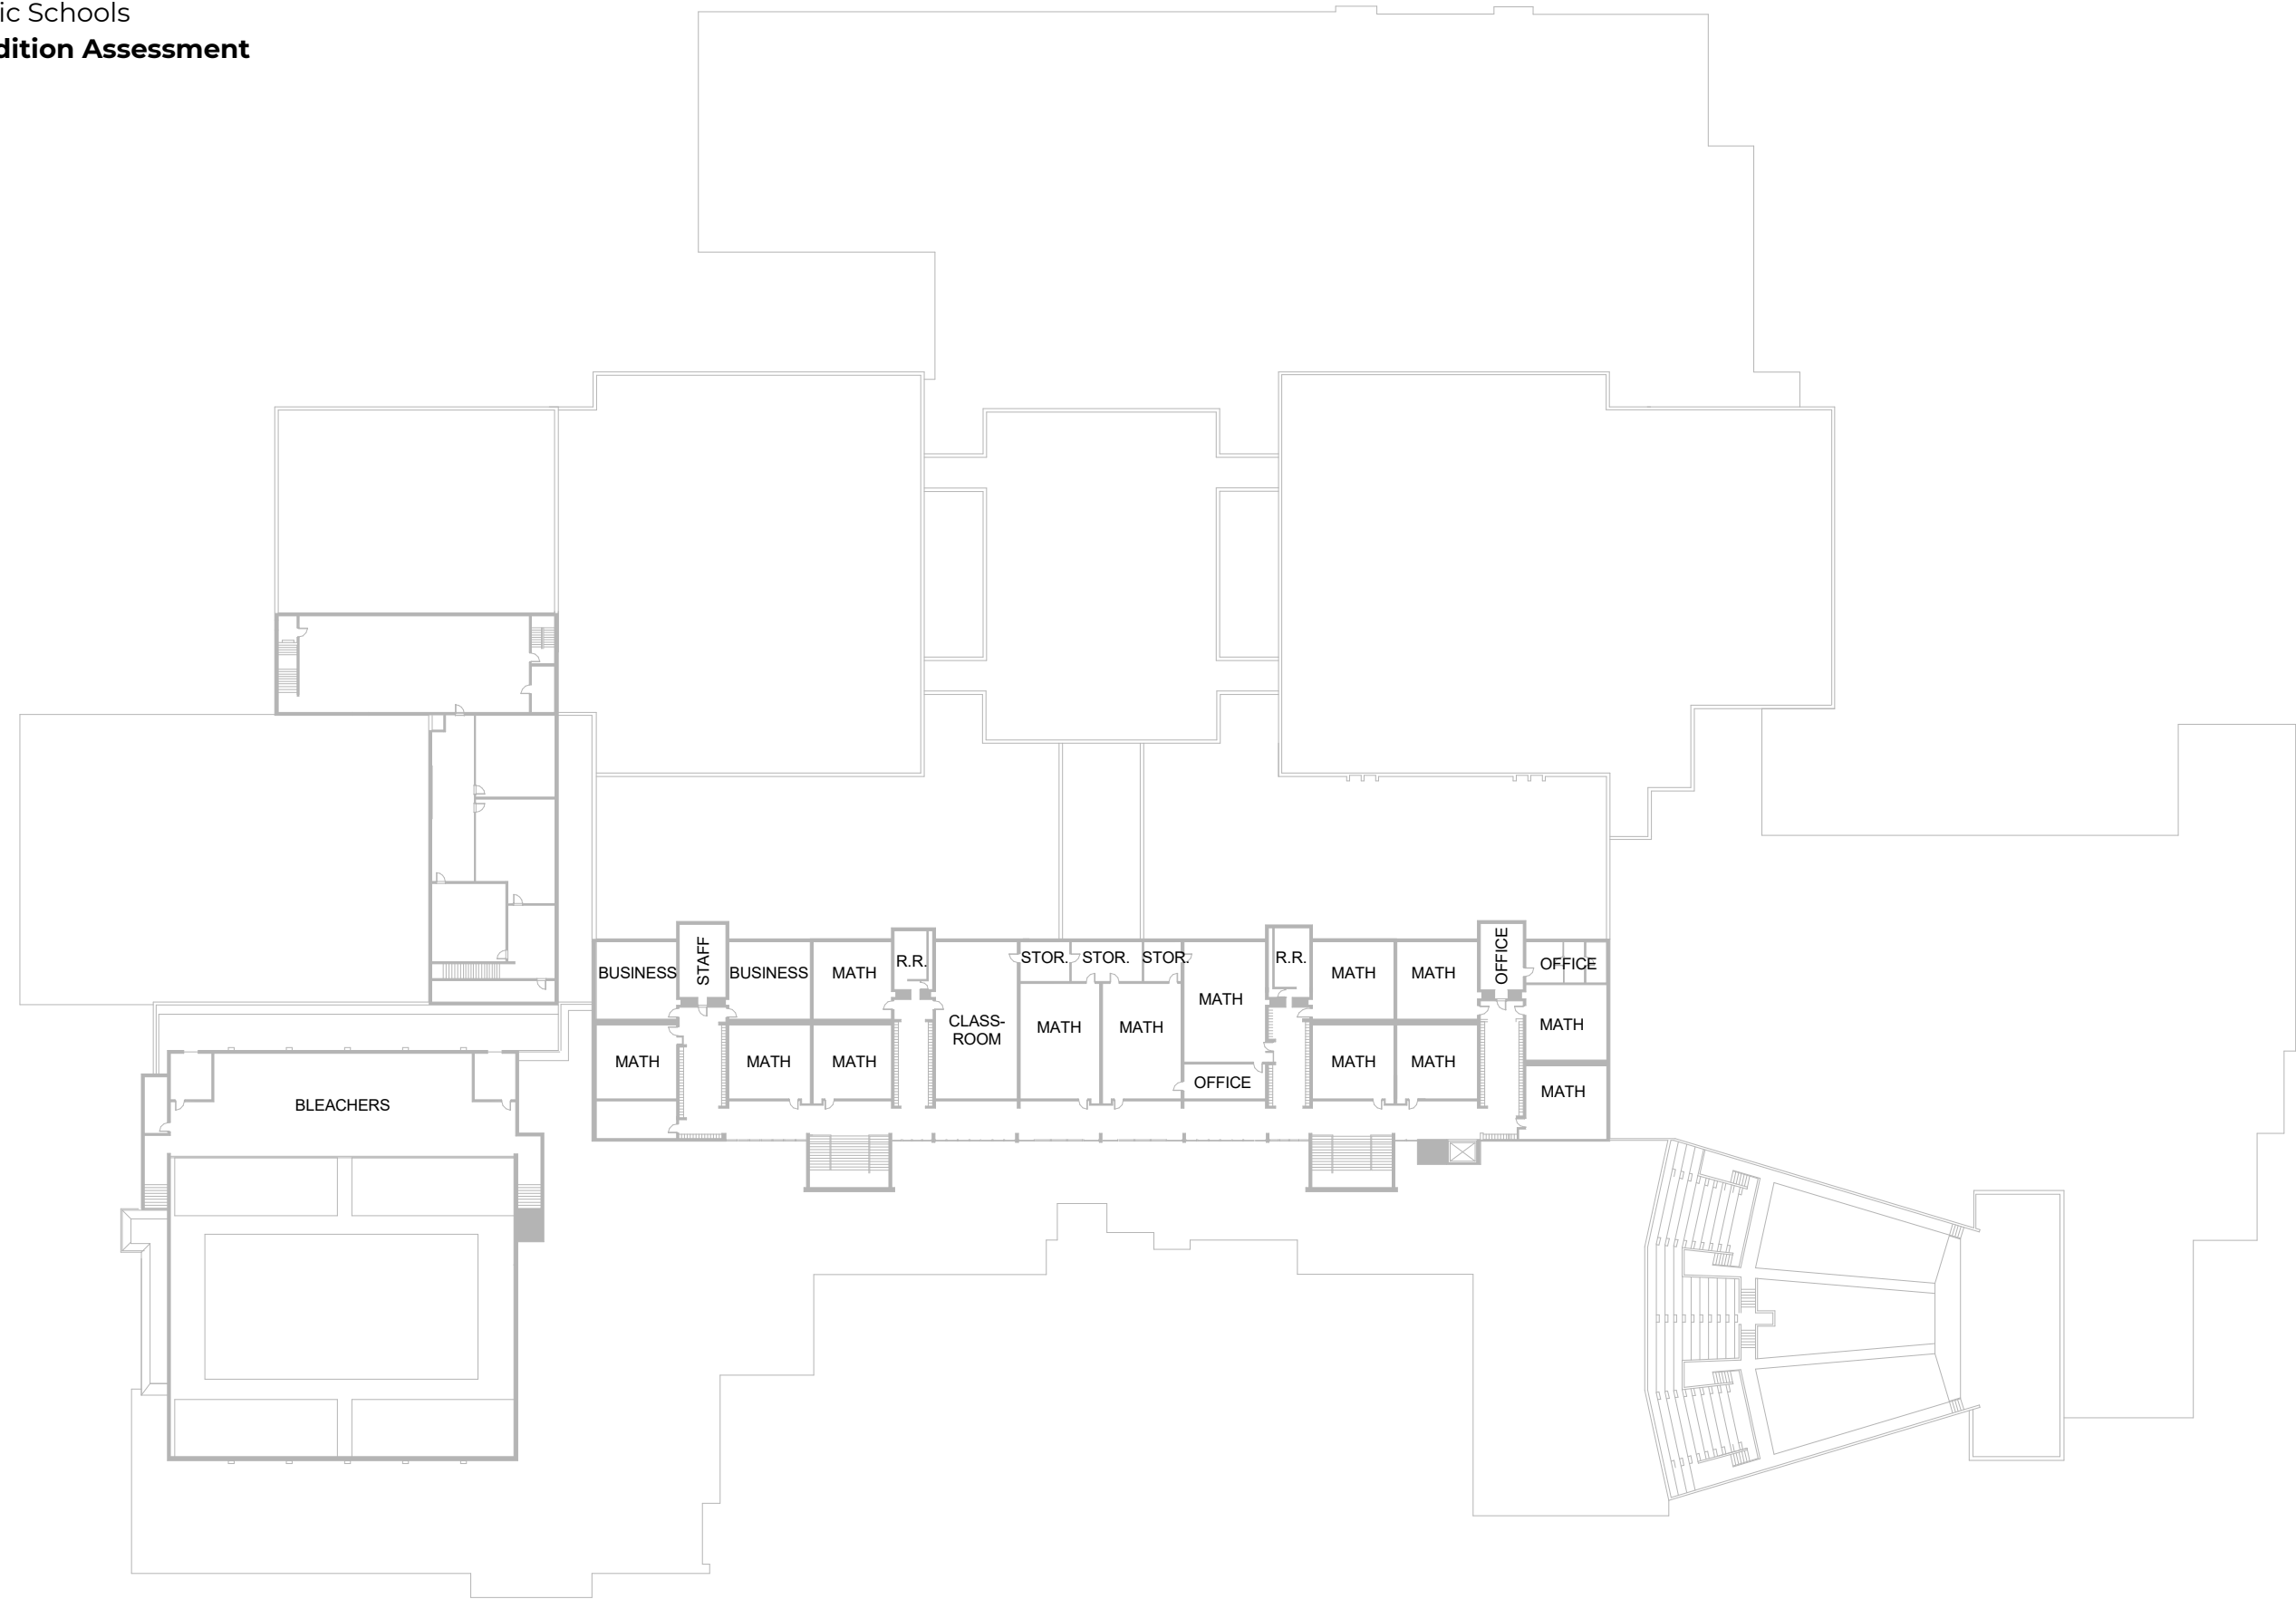
**10.Kitchen**

- Circulation is very tight in the servery between serving lines and on the path to the cashier.
- One serving piece is from another school and is not the correct height for a high school and should be replaced.
- Dishwasher, soiled dish table and rolling shutter are in disrepair and should be repaired or replaced.
- Walk-in cooler threshold is rusting and should be repaired.
- Some ceiling tiles are showing wear/damage and should be replaced.
- Ovens and range may need to be replaced due to age.

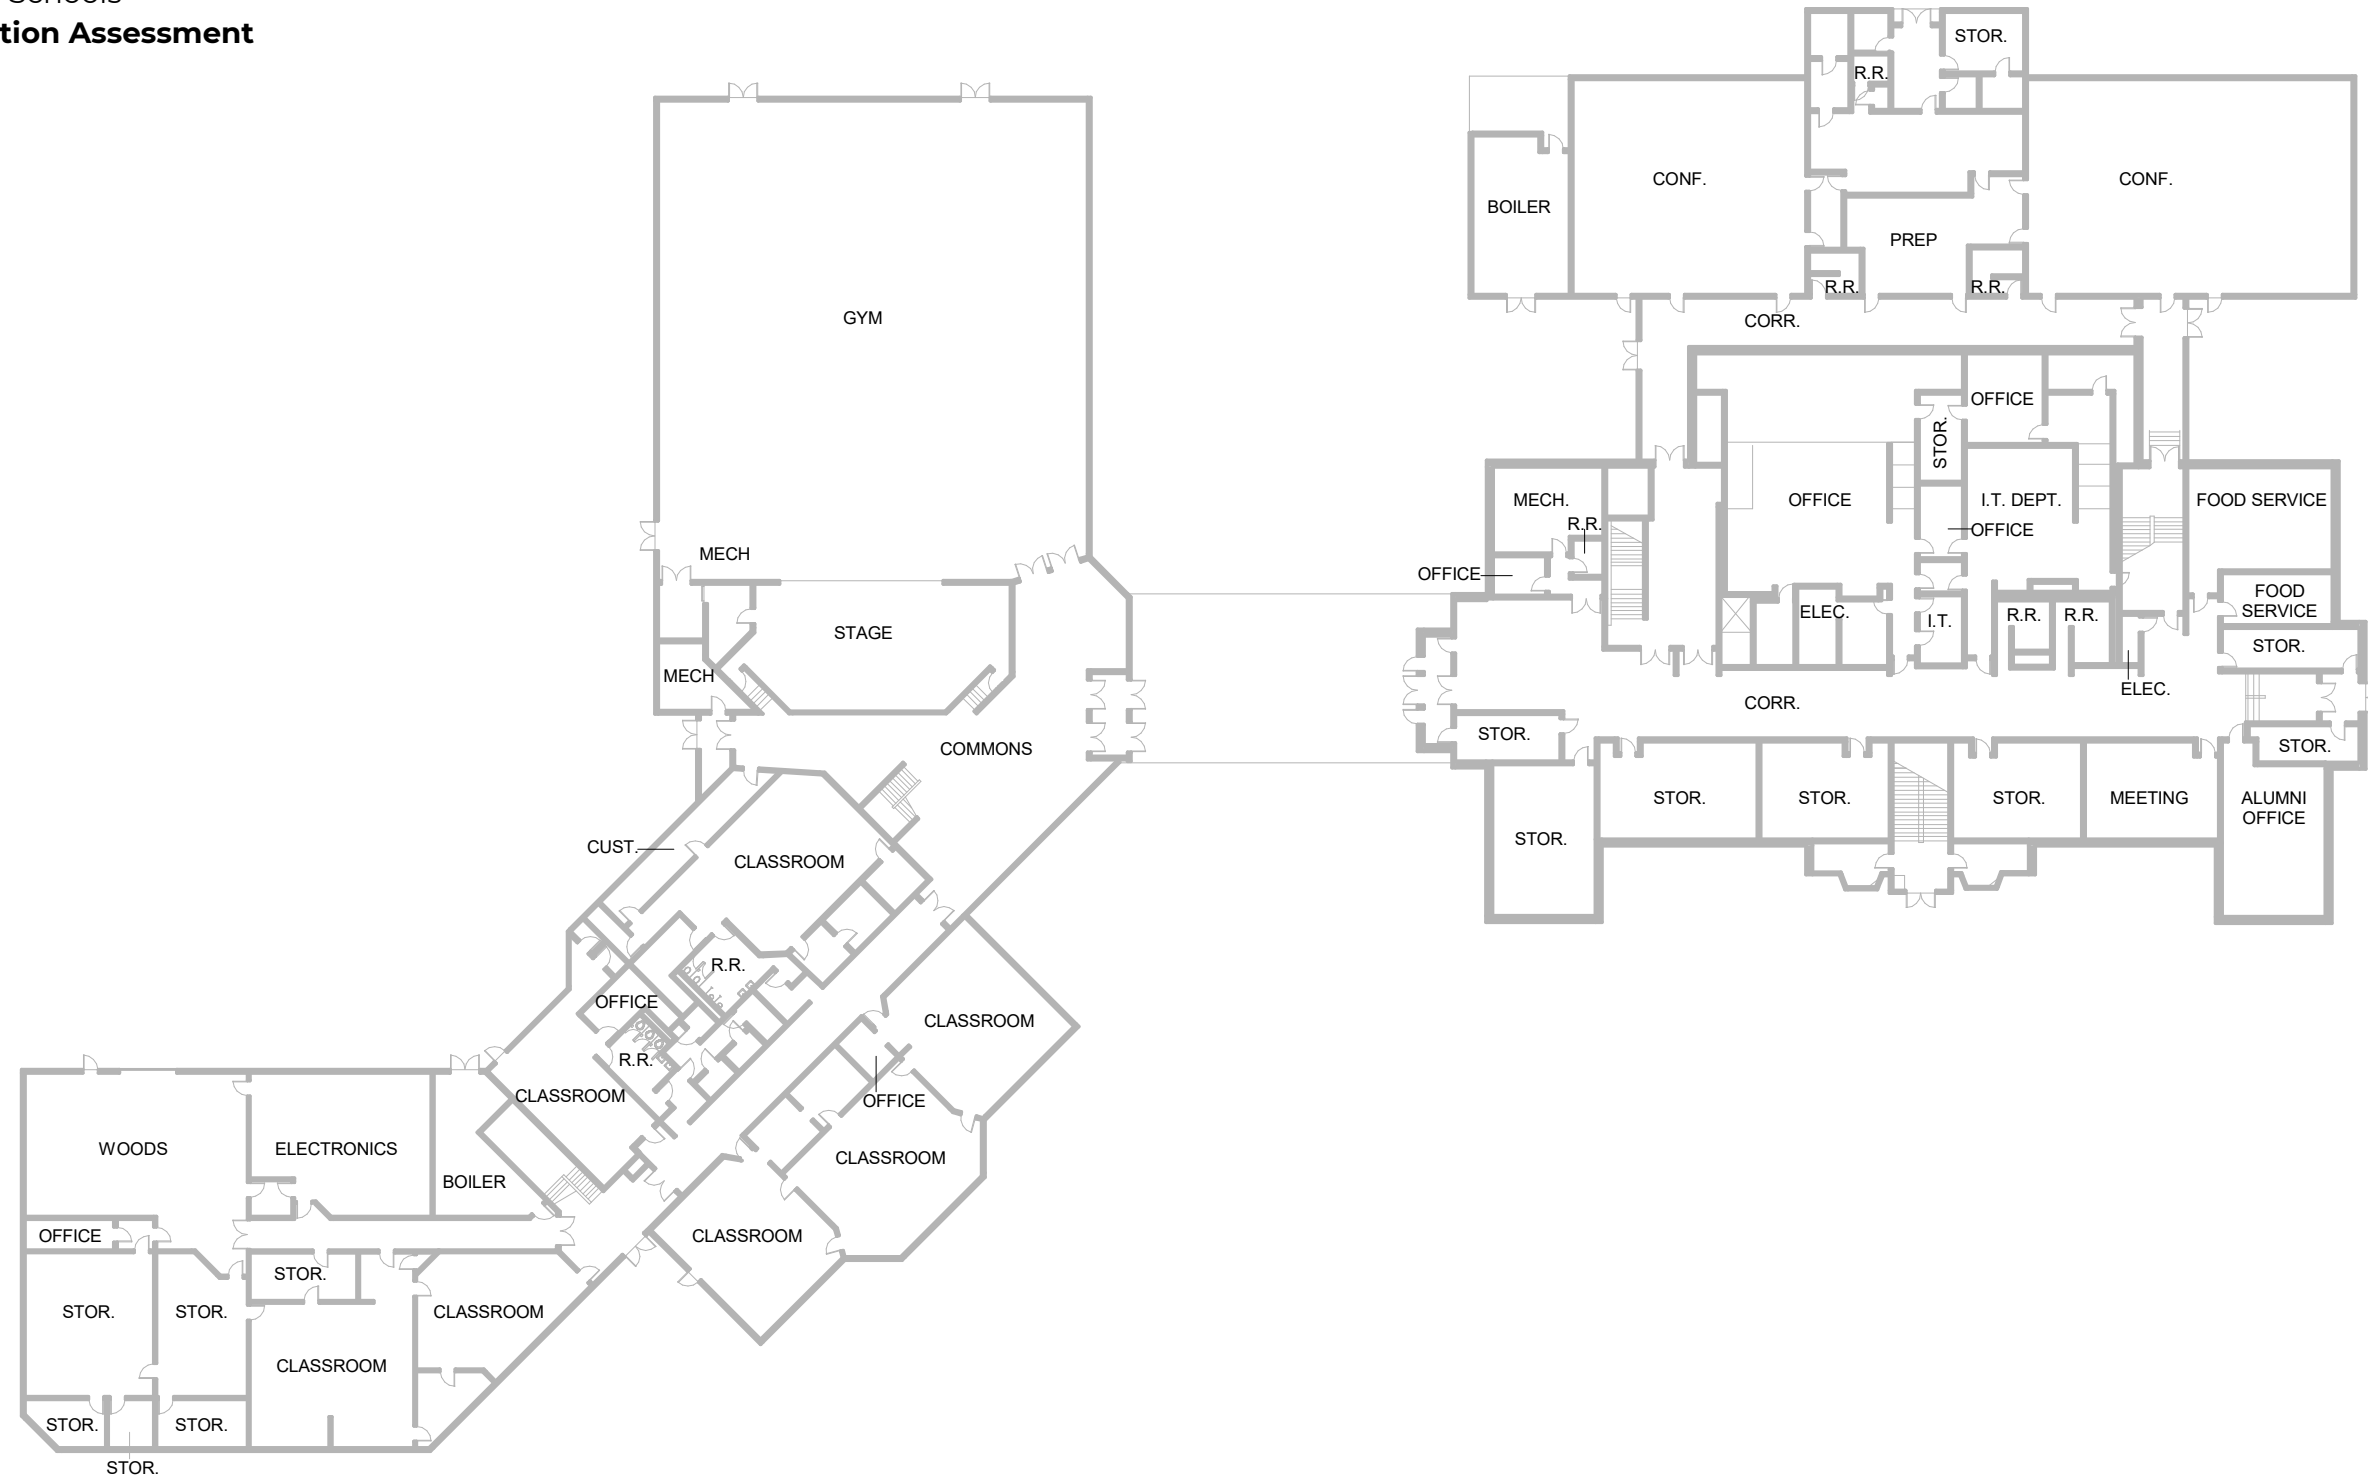
## **10. Kitchen**

- Kitchen is located within a working classroom and consists of all residential equipment and wood cabinetry. Facility acts as a serving kitchen only (according to a staff member present during my visit) but despite that, code requires commercial-grade equipment.
- There is only one sink serving as a hand sink, prep sink and warewash.
- Existing exhaust hood is from the room's former use as a woodshop and spans the entire kitchen area.
